Three-Tab Shingle Performance During Hurricane Ivan, 2004

By David Rash, RRC, Assoc. AIA

Hurricane Ivan's rampage through the southeastern portion of the United States in September 2004 provided an opportunity to observe the real-world performance of this ubiquitous roofing material as it relates to age. In the city of Mobile, Alabama, an 18-building housing complex had shingles from three distinct installations with a similar level of workmanship prevailing throughout the complex (Photo 1). That there was a correlation between age and performance was not a surprise. What was unexpected was how well the shingles performed, despite their age and poor installation.

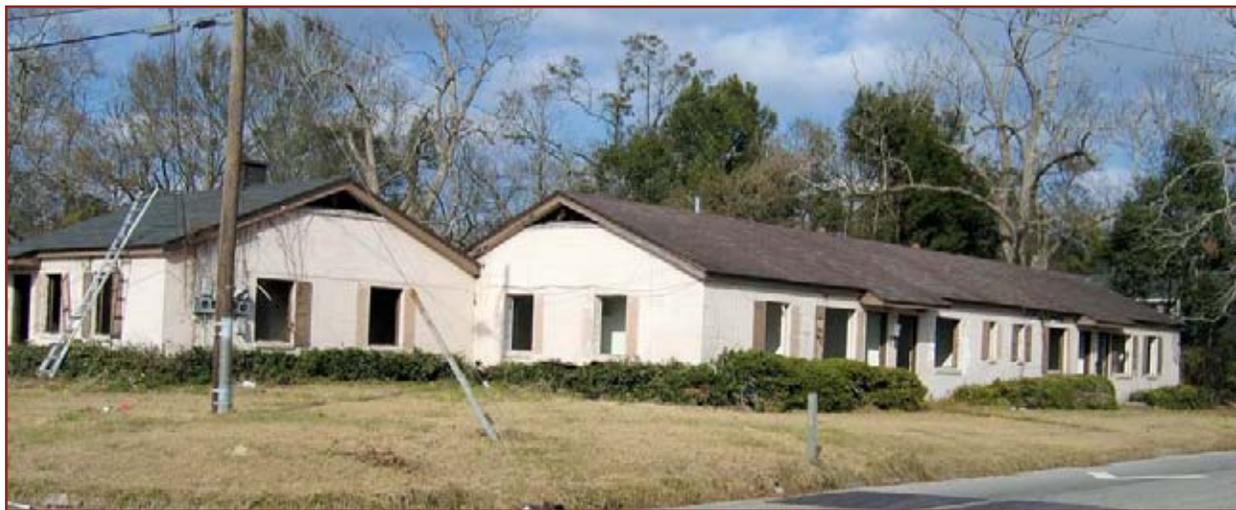
Photo 1 – Typical configuration and condition of building structure within the housing complex.

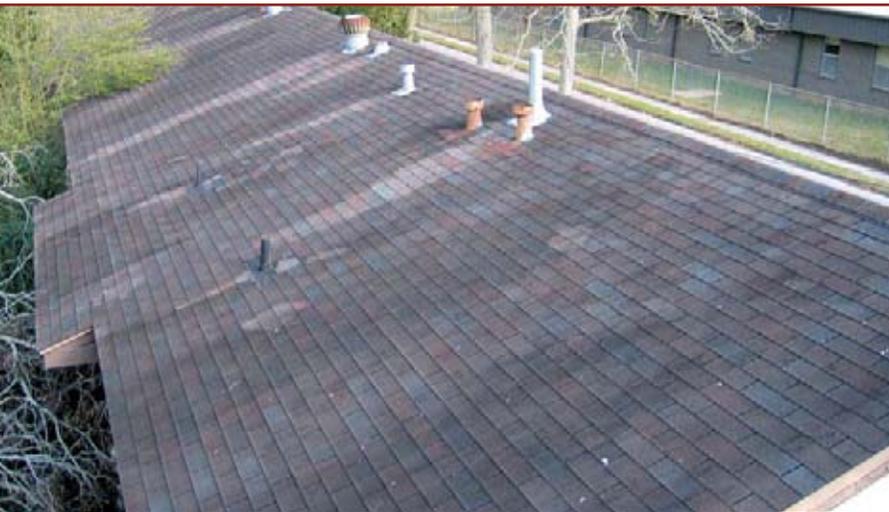
Photo 2 (left) – The long wing of Building 1 had an “old” shingle roof, typical of nine buildings in the complex.

The total ground area covered by buildings was approximately 48,971 square feet. The total sloped area of roofs covered with three-tab, asphalt-composition shingles was approximately 58,535 square feet. The ages of the shingled roofs were unknown. Topical observation suggested that some of the roofs might have been part of the original (30+ year construction) and are noted in this paper as “old” (see *Photo 2*). Some shingles were definitely installed recently (less than five years ago), and are noted in this paper as “recent” (see *Photo 3*). Other shingles were likely of less recent installation but not original construction (10 to 15 years old), which are noted in this paper as “moderately old” (*Photo 4*).

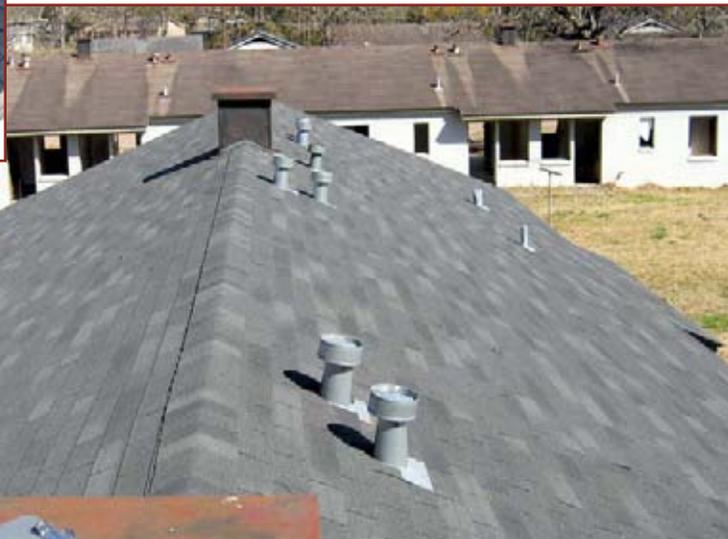
Below: Photo 4 – The long wing of Building 16 had a “moderately old” shingle roof, typical of five buildings in the complex.

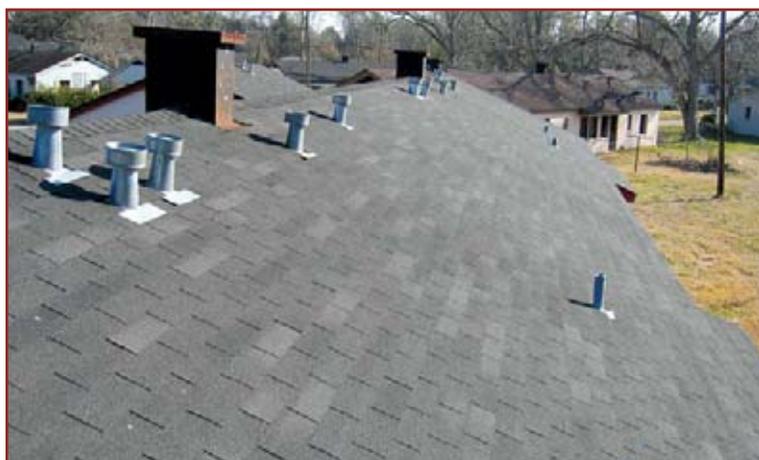
Photo 3 – The center wing of Building 12 had a “recent” shingle roof typical of four buildings within the complex.

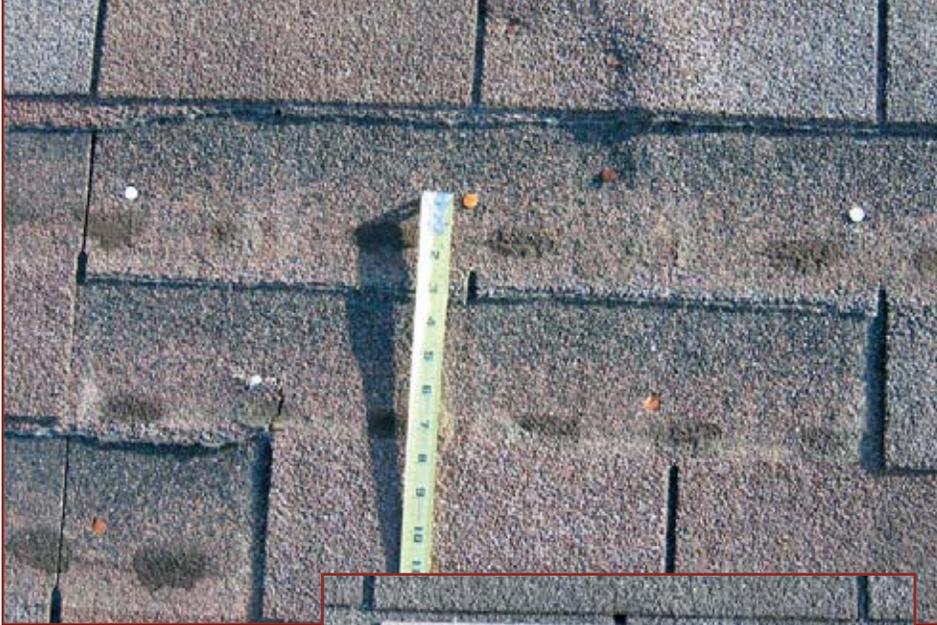
Above: Photo 5 – Nails were underdriven and located too high with the “old” shingle roof installation on Building 10.

weather. Lightly rusted or non-rusted nail heads would suggest recent exposure; heavily rusted nail heads would suggest exposure prior to the hurricane. In addition, in some areas where shingles were recently lost due to a wind event, installation deficiencies undoubtedly contributed to the shingle loss. In particular, under-driven nails or nails located so high as to secure only one layer of shingles, rather than the intended two layers, resulted in roofs susceptible to wind damage (Photos 5, 6, and 7).

that were observed where wind loss had occurred – the most notable deficiencies being nails placed too high or missing altogether. These particular deficiencies resulted in shingles with too few fasteners to adequately resist wind uplift.

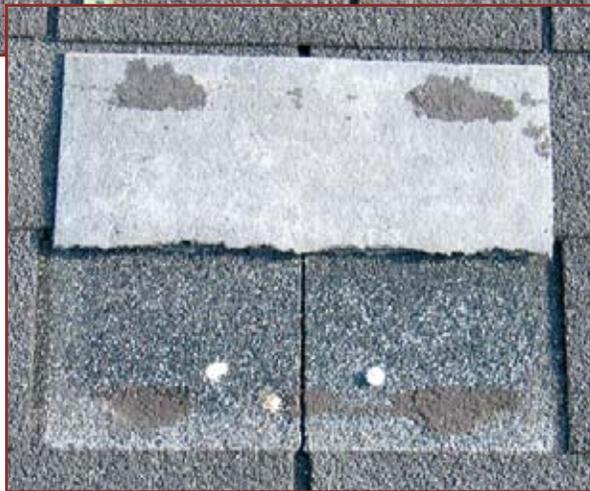
Above: Photo 6 – Nails were underdriven and located too high with the “moderately old” shingle roof installation on Building 2.

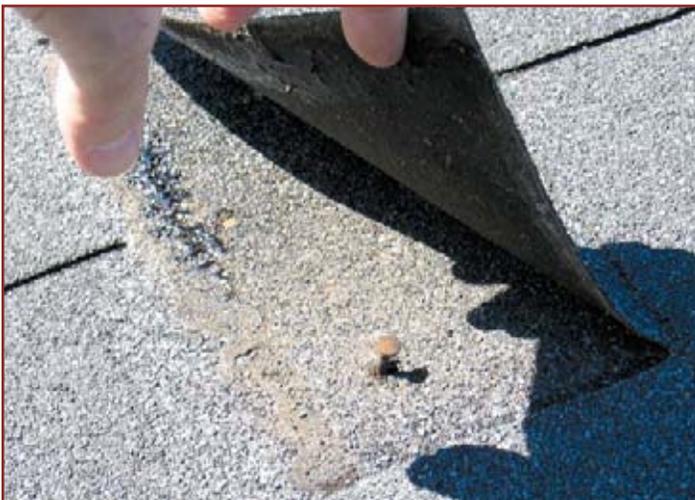
Photo 7 – Nails were underdriven and located too high with the “recent” shingle roof installation on Building 15.

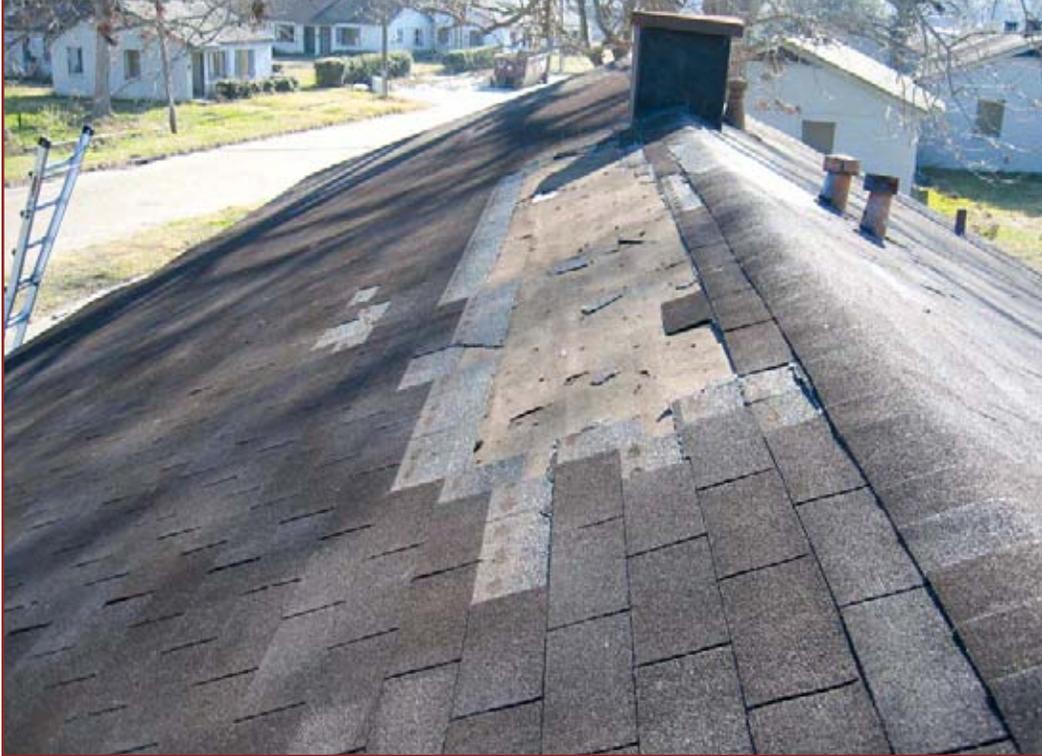
Left: Photo 8 – The most extensive wind loss of shingles occurred near the roof perimeter and with the “old” shingles, such as on Building 13.

nificant damage to the shingled roofs outside of vandalism and age. Uplift forces near the perimeter of the roof structures were sufficient to remove shingle tabs from portions of some roofs, particularly the older ones (Photos 8, 9 and 10).

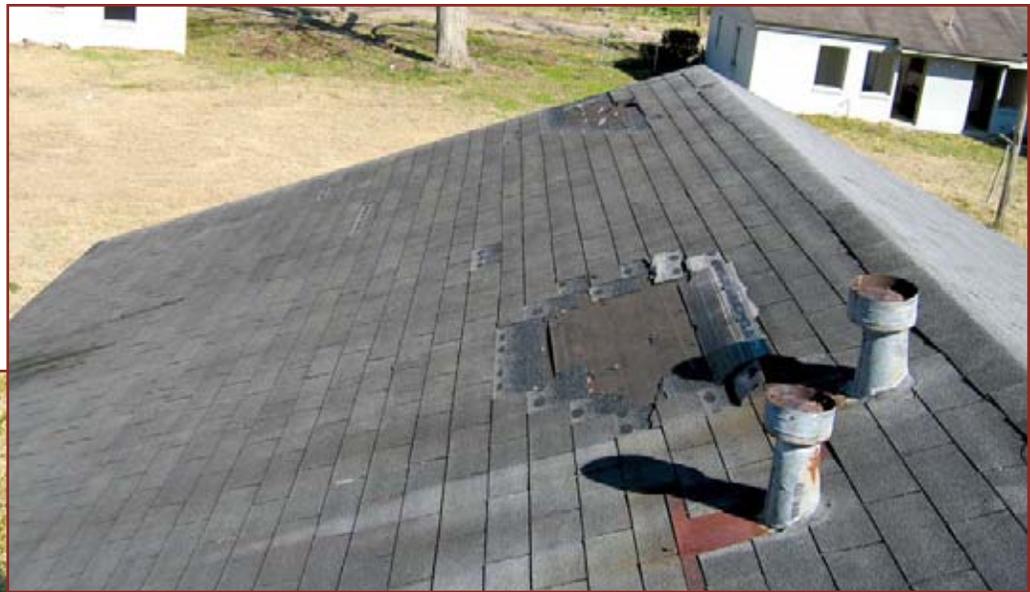
Above: Photo 9 – Less extensive wind loss of shingles occurred with the “moderately old” shingles, primarily near the roof perimeter, such as on Building 18.

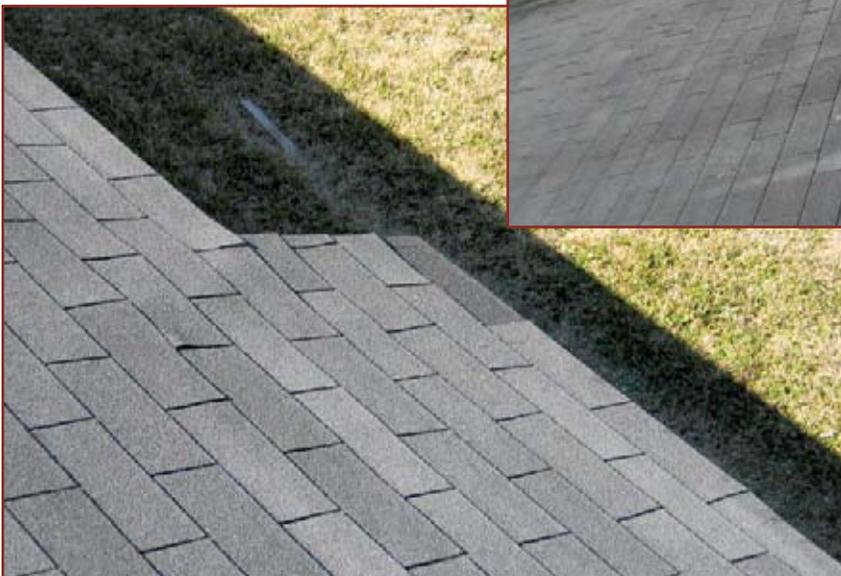
Photo 10 – Very little wind loss of shingles occurred with the “recent” shingles, such as on Building 15.

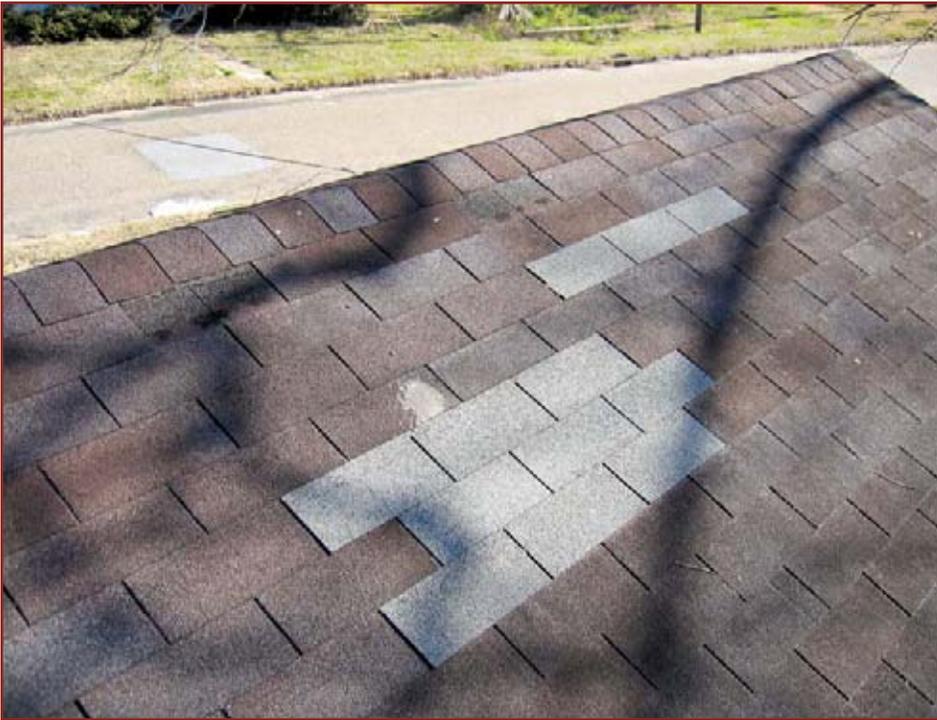
Photo 11 – Despite overexposure, repaired portions of “old” shingle roofs performed well during the hurricane, such as these repairs on Building 13.

portion of this report. In determining what might be appropriate in regards to repairs, we have based our suggestions for repairs on the types of maintenance repairs previously performed at the site. In regard to the roofs, many existing roofs have had damaged or lost shingle tabs replaced by indi-

vidual shingle tabs rather than full roof replacement (*Photo 11*). Only Building 3 (which suffered structural damage from a fallen tree, *Photo 12*) sustained sufficient damage to warrant full replacement of the shingles on the roof. Only three of the 18

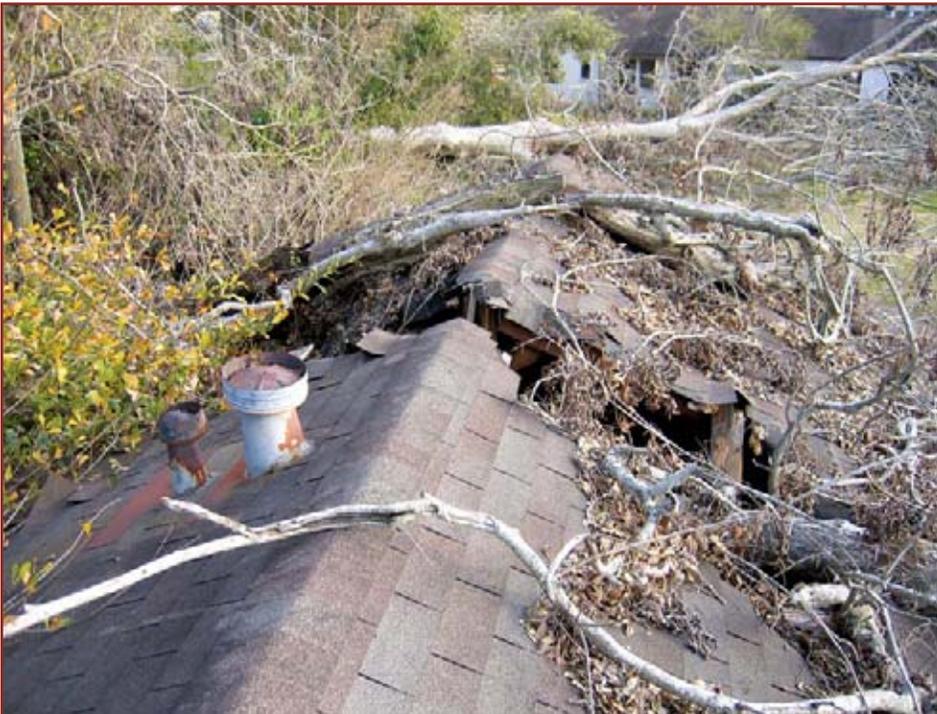
Photo 12 – Although the “old” shingles on Building 3 suffered very little direct wind damage, structural damage from this fallen tree would necessitate replacement of the shingles.

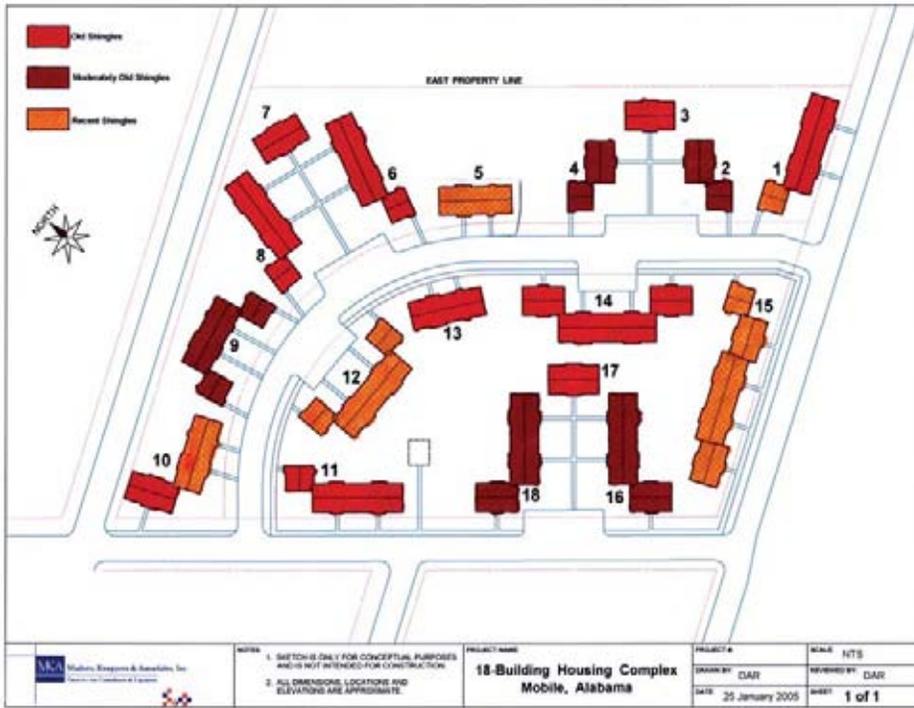
Figure 1 – The “old,” “moderately old,” and “recent” shingle roofs were each widely distributed throughout the housing complex, as can be seen with the project site plan.

three buildings had “old” shingles (see Figure 1). For a complete breakdown of shingle loss per building, see Table 1 for a building breakdown and Table 2 for unit breakdown.
