# ENEMIES OF THE ROOF

BY JOHN W. WELLS, RRO

The case study presented here is based on a real-world investigation recently performed by Wells Klein Consulting Group (WKCG) on a building on the west coast of British Columbia. Brief portions of the report are excerpted and italicized herein.

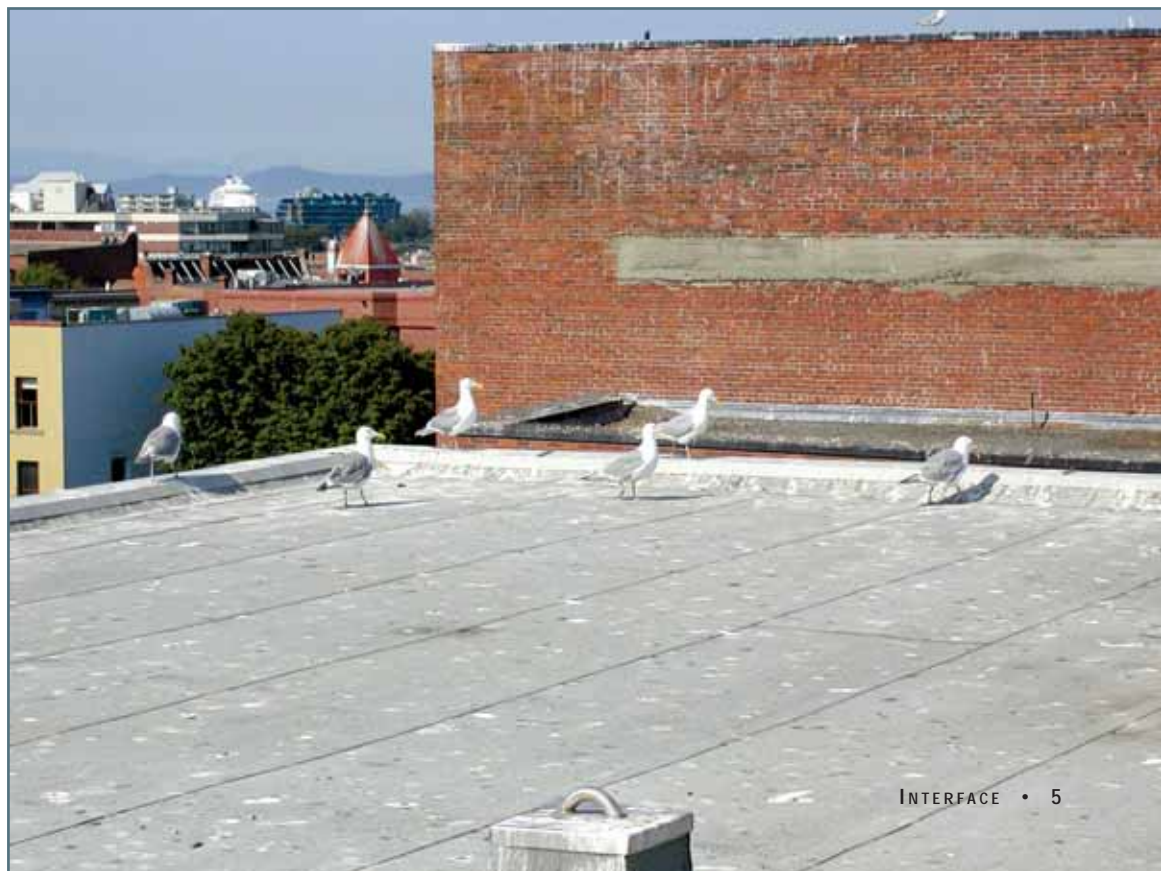
Numerous articles on roof maintenance have been written over the last few years, including many by this author. The topic of this dissertation, however, spotlights a different area of roof maintenance than is usually explored: protection from birds, especially particular species (see *Photo 1*).

*Photo 1 – Gulls are sociable birds.*

*They like to roost on a place higher than their nests, where they can see the nesting area. In this case, the area is below and to the right on a nearby building.*

*Unfortunately, this “sociability” includes another function.*

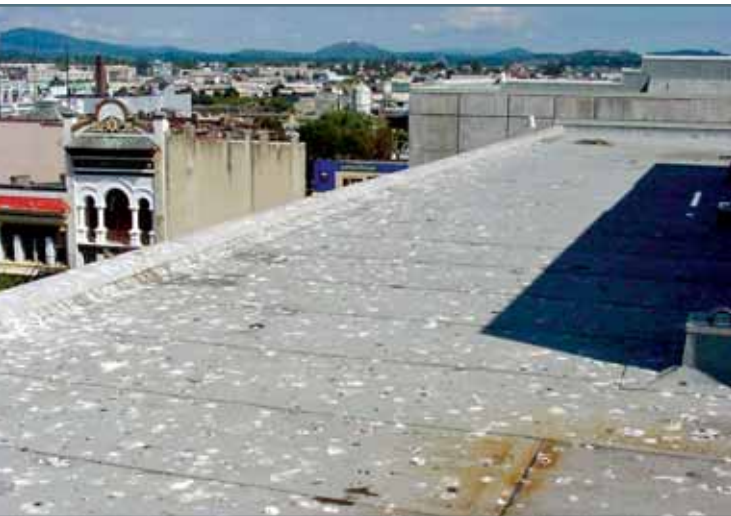
in certain locales and conditions, revealed a unique limitation with these materials. Concentrations of bird droppings can contribute to the rapid removal of the granule cover. The surface granules on the top ply or cap sheet supply the UV resistance to the membrane assembly and are a critical item in the long-term performance and life expectancy of the roof membrane assembly. Degradation caused by bird droppings can expose the asphalt beneath to localized UV deterioration (see *Photo 2*).

*Photo 2 – The amount of fecal matter and damage discovered on the first site visit was quite astonishing... and the smell wasn't great either!*

*“This new roof exhibits one of the most severe bird dropping problems that this consultant has viewed. Significant and severe damage has occurred to the membrane and its protective granules.”*

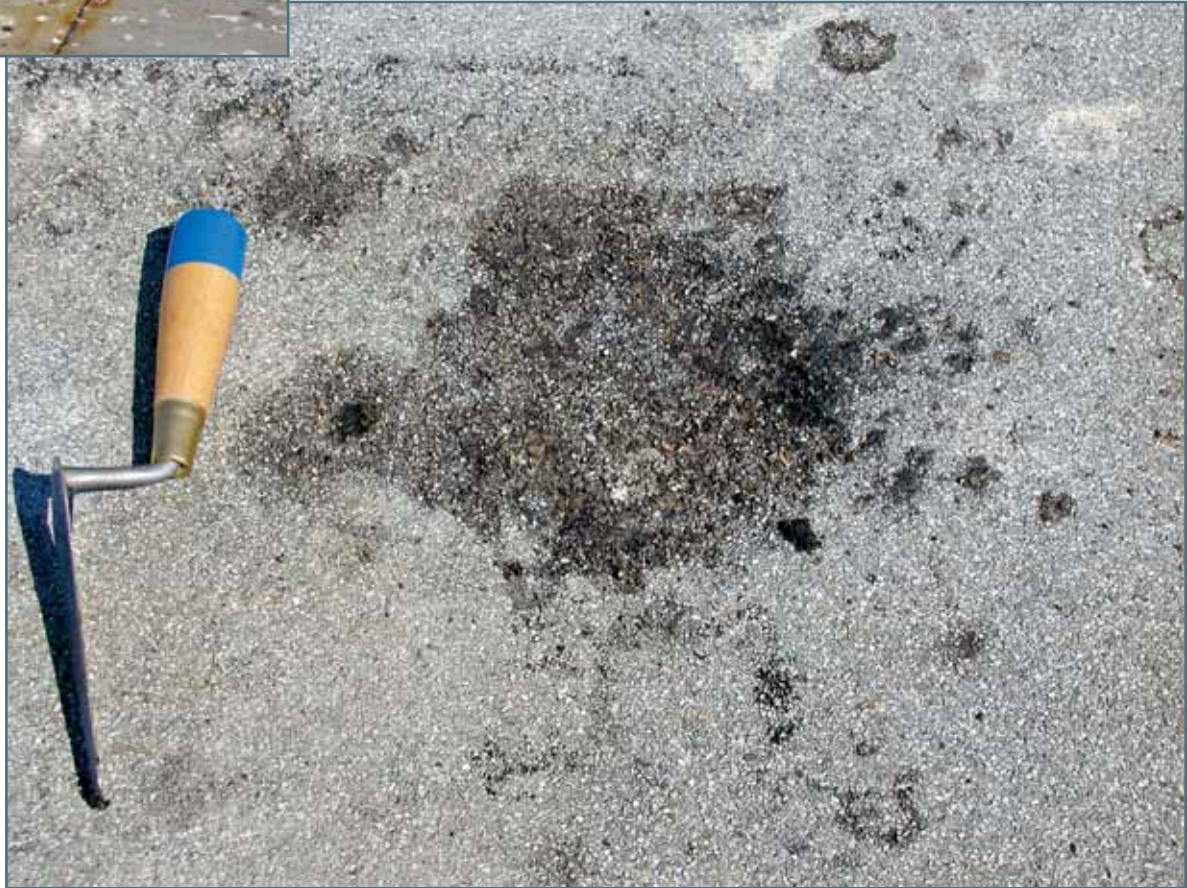
*Photo 3 – This picture demonstrates damage to the membrane that almost reaches the reinforcing mat. Granular degradation is devastating; the asphalt blend is softened and contaminated.*

In many spots, the effects of the droppings had actually not only removed granules, but softened or affected the top portion of the asphalt membrane proper, similar to hydrocarbon or oil contamination. In limited locations, membrane reinforcing had been exposed, indicating the erosion (removal) of granules and perhaps 1.5mm of asphalt sheet! (See Photo 3.)

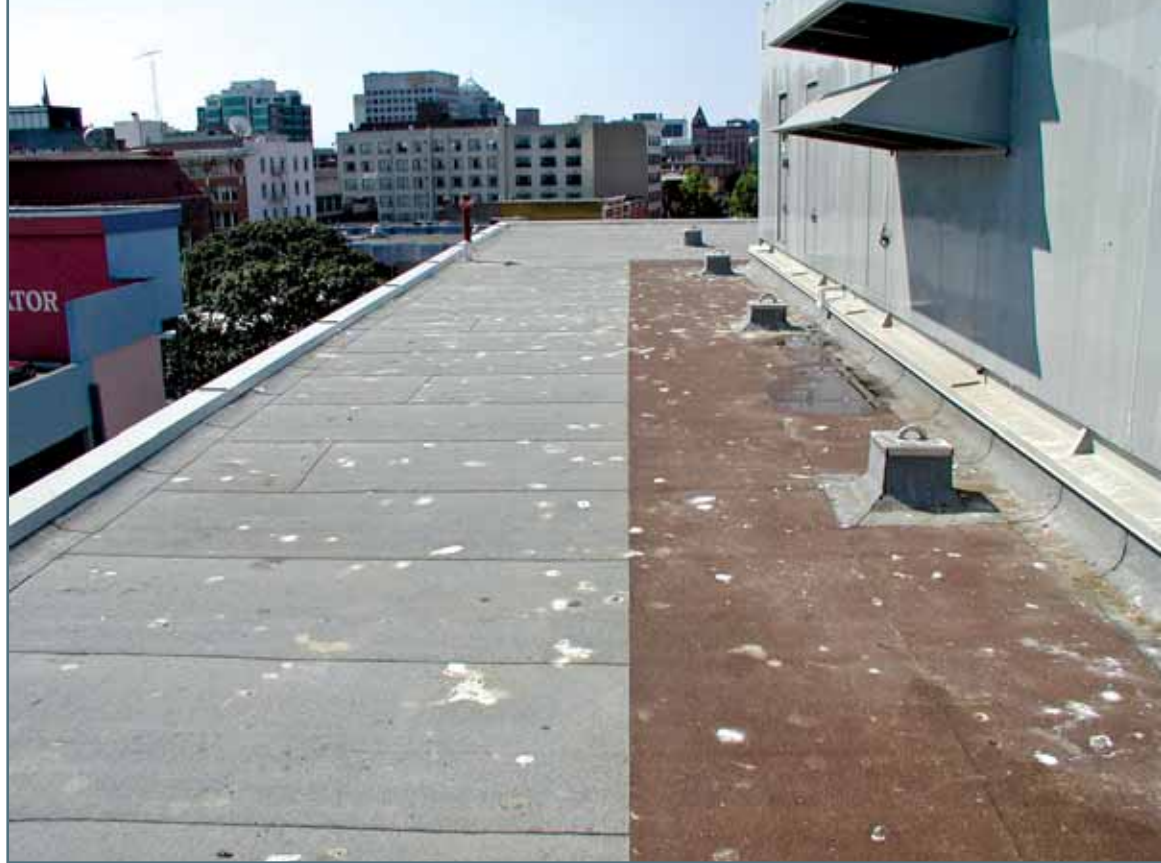
Direct contact or contact through airborne sources must be considered. A direct source can be something as simple as tracking fecal matter on shoes from innocent contact on the roof. Airborne sources are through air handling and HVAC equipment (see Photo 4).

*Photo 4 – Given the amount of fecal matter, a dry weather spell, and then a rainstorm, the air intakes can (and did!) draw some very objectionable odors into the building, to say nothing of the bacterial problems.*

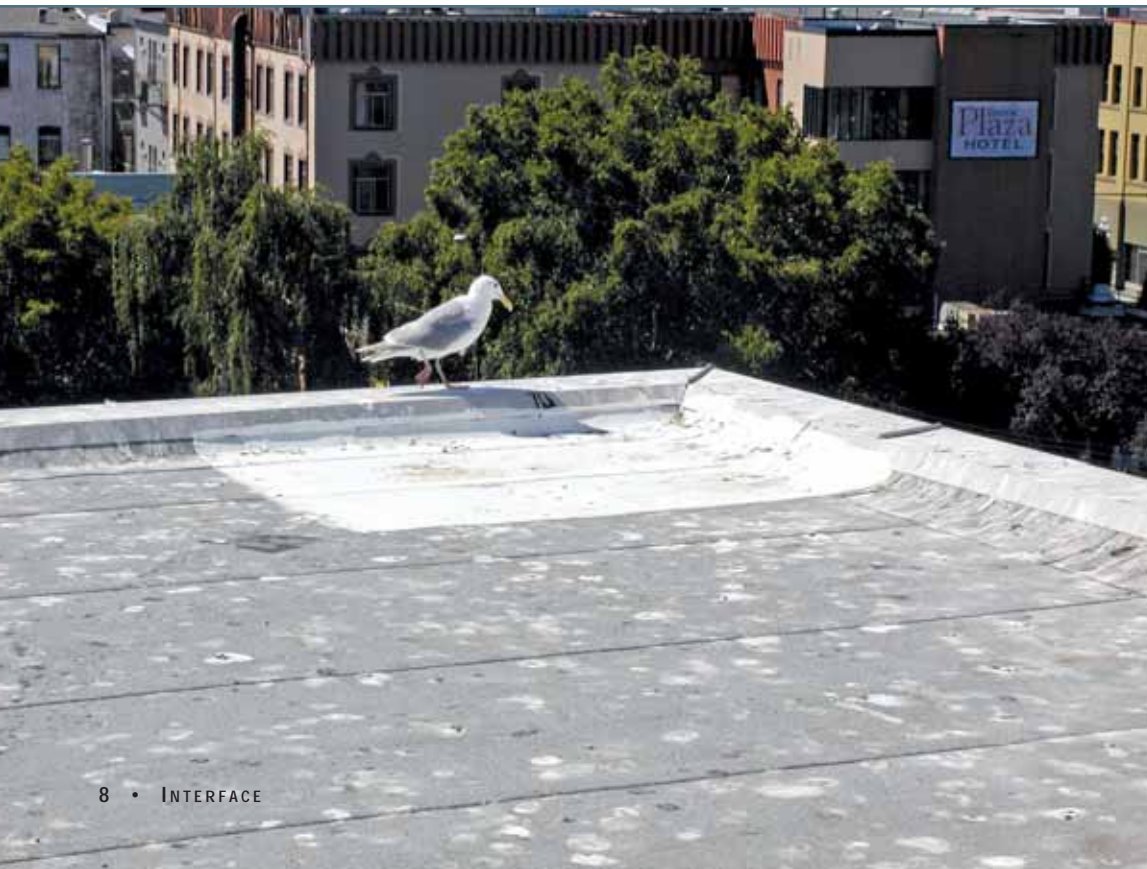
*Photo 5 – One of the attempts to “fix” the problem was an elastomeric coating. As demonstrated, the birds loved it. This particular coating proved ineffective.*

Membrane repairs on this building will be extensive and expensive in order to restore the roof to any semblance of its normal life expectancy. Specialized elastomeric coatings (see *Photo 5*), methacrylate coatings, an additional layer of cap sheet, or even the addition of a hot asphalt pour coat and gravel surfacing are plausible considerations.

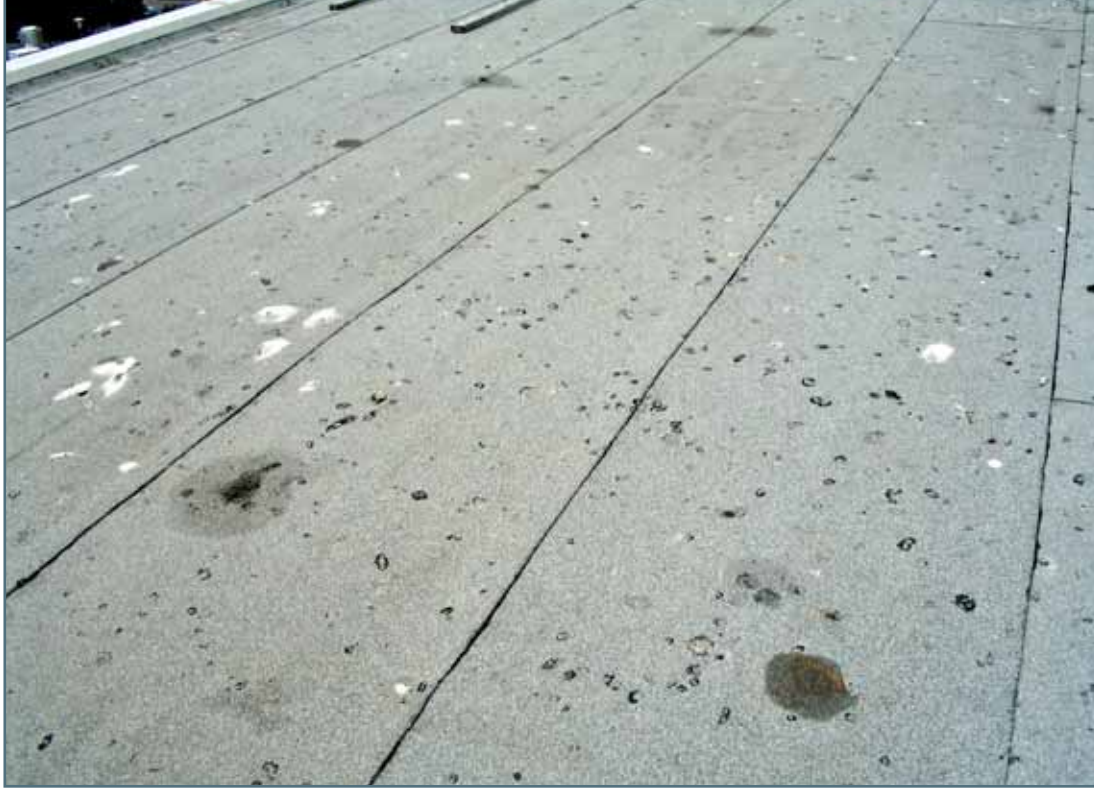
*Photo 6 – This photo was taken after the roof had been well washed by rain. The small, round marks are typical of granule loss damage to modified bitumen membrane caused by gull droppings. The larger, “splotchy” marks exhibit damage to the actual membrane, down to the reinforcing, in some locations. Some of what these birds eat and defecate dissolves or softens asphalt!*

Regular inspection and very careful surface washing (in dry times when rain is not a regular occurrence) may be required in

order to keep the build-up of fecal matter to a minimum. Even if the coating protects the membrane as envisioned, the bird droppings will still have to be eliminated if further build-ups occur. Extreme care must be taken not to remove protective granules

unless another protective measure is identified (see *Photo 6*).
