CURTAIN WALL SUNSHADE CHALLENGES

MARK K. SCHMIDT, PE, SE, AND OANA A. TOMA

Building Envelope Technology Symposium

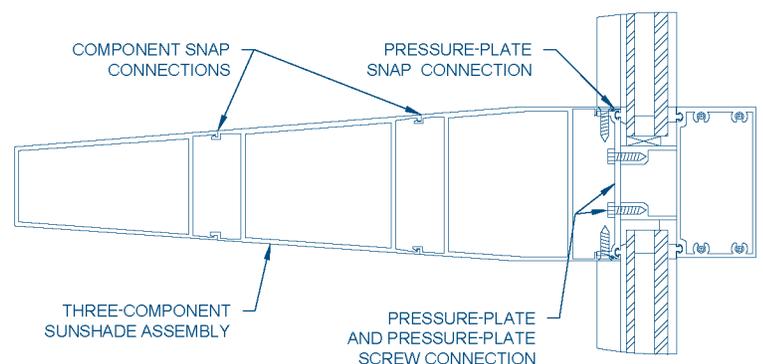
the ocean. A cross section of a typical sunshade is shown in *Figure 1*. The sunshades are two windows wide, spanning across an intermediate vertical mullion. Each sunshade is comprised of three aluminum components that are joined by snap connections (hereafter termed “component snap connections”). The three-component, shop-assembled sunshade is attached to two horizontal aluminum pressure plates—one along each window opening—via a snap connection (hereafter termed “pressure plate snap connection”). At each end of each pressure plate, there are screws installed in countersunk holes at the top and bottom of the sunshade in an effort to prevent disengagement of the pressure-plate snap connection at these locations, as shown in *Figure 1*. Each pressure plate is attached to a horizontal aluminum mullion with two rows of stainless-steel screws, spaced at 12 in. on center, which engage dual screw chases in the mullion (hereafter termed “pressure-plate screw connection”).

Figure 1 – Typical sunshade cross section.

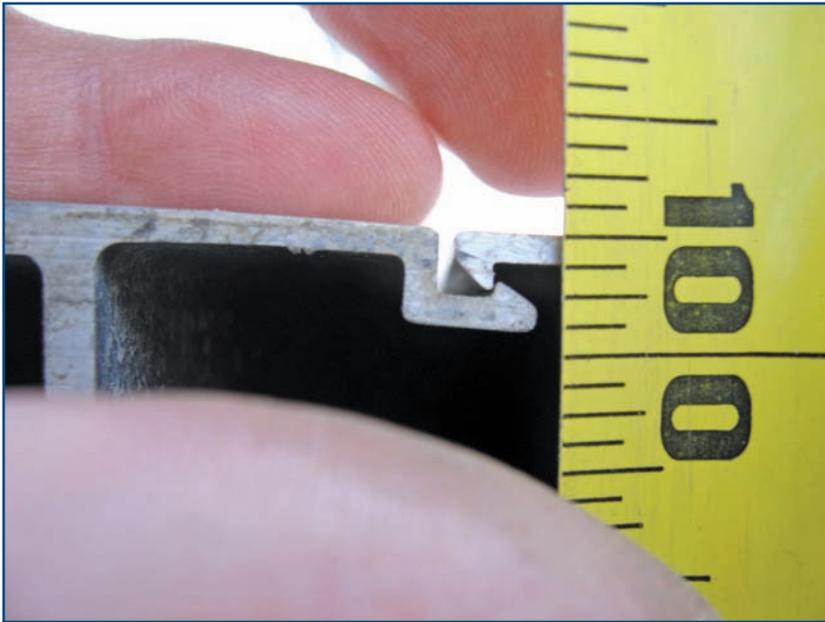
Figure 2 – Approximately 1/32-in. engagement of component snap connection.

Inspections of intact sunshades revealed limited engagement of component snap connections, as shown in *Figure 2*. Avenues for water penetration into the component snap connections, as well as the pressure plate snap connections (*Figure 3*), were evident. Though these conditions were installed in conformance with the shop drawings, trapped water could freeze and cause localized disengagement of the snap connections. At one sunshade with failed component-snap connections, the pressure-plate snap connection was also partially disengaged, and the remaining sunshade component was easily disconnected from the pressure plate. Dust and small debris were observed at the disconnected pressure-plate snap connection, as shown in *Figure 4*. Similar conditions were noted at other sunshade-snap connections.

The most likely cause of failure for most of the sunshades was the partial disengagement of snap connections, which failed under the sunshade self-weight and minimal snow accumulation. Factors con-

tributing to this disengagement may have included moisture (freeze-thaw) and thermal cycles, incomplete engagement during initial installation, die tolerances, differential movements between the sunshade and the supporting strip-window framing, and potential impact loads from small amounts of falling snow/ice. The fact that the failure occurred during conditions favorable to freezing and thawing suggests that expansive forces of ice within the snap connections played a significant role.

To remediate the connection deficiencies of the existing sunshades (vulnerable snap connections and stripped/corroding pressure plate screw connections), additional connections and anchorages were installed and load-tested prior to widespread application on the façade.

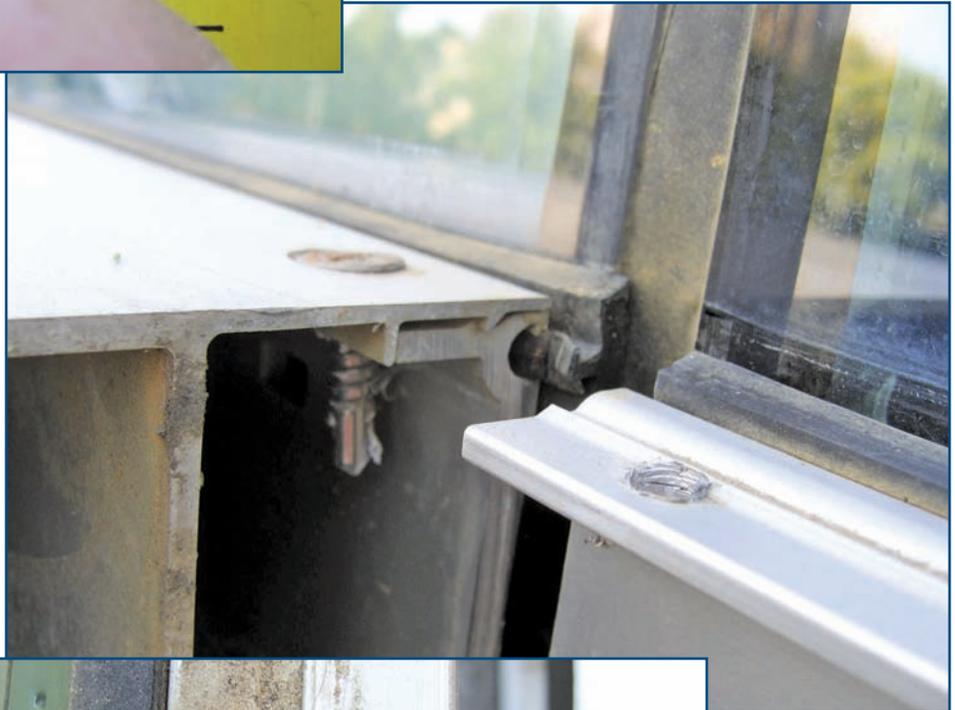
Figure 3 – Upper pressure-plate snap connection with avenues for water penetration through open ends and along gasket between pressure plate and glass.

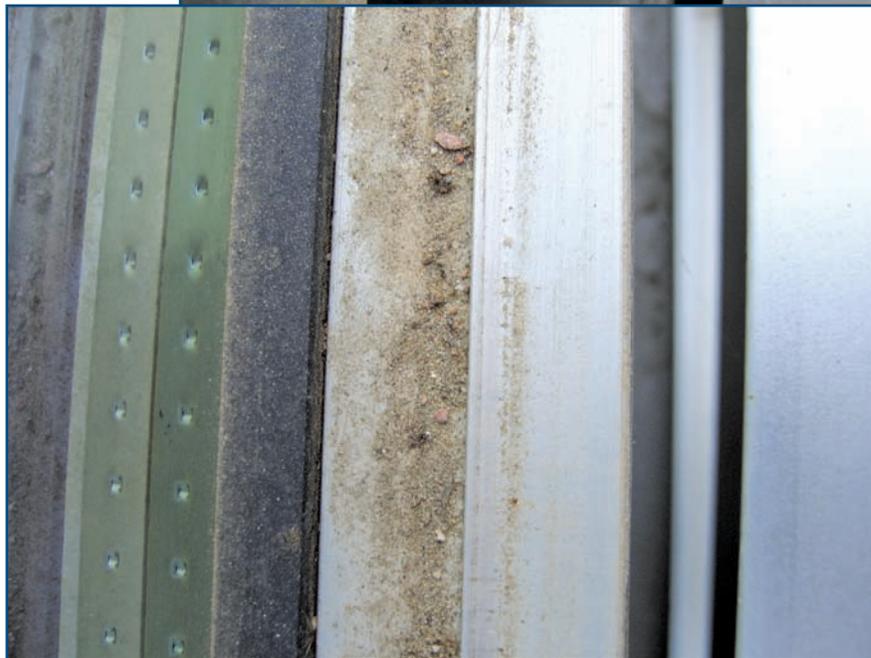
Figure 4 – Dust/debris within disassembled snap connection.

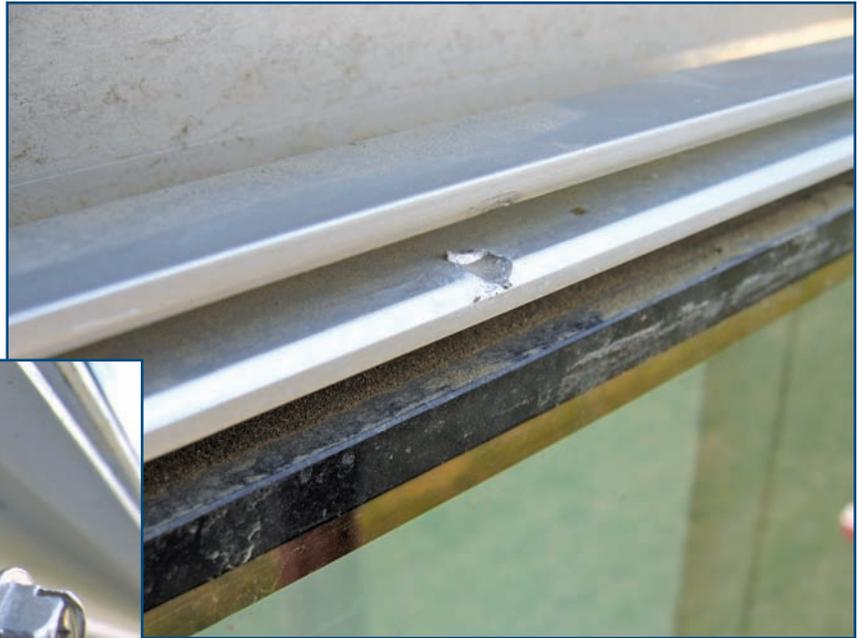
At the sunshade where failure occurred at the pressure-plate screw connection, the tapped aluminum of the screw chase was stripped (*Figure 5*). Upon disassembly of additional sunshades, it was noted that the screw chase was stripped at several screw locations. During removal and reinstallation of the pressure plates, it was determined that these con-

Figure 5 – Stripped aluminum screw chase at failed pressure-plate screw connection.

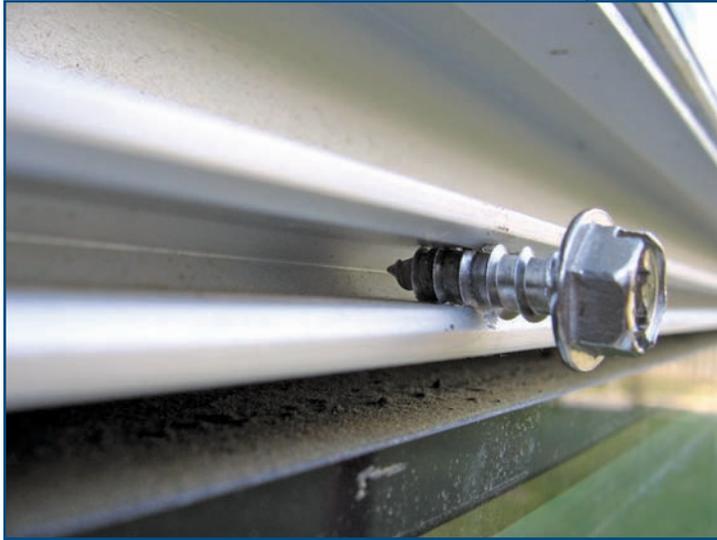
Figure 6 – Typical engagement of pressure-plate screw in chase (pressure plate not shown).

nections could be easily stripped due to the relatively shallow engagement of the pressure-plate screws and the somewhat oversized screw chase (*Figure 6*). Corrosion of the aluminum screw chase was noted at nearly all of the upper screw sites at the sunshade with the pressure-plate screw connection failure. Many stainless-steel pressure-plate screw sites exhibited similar corrosion; *Figure 7* illustrates a location with relatively severe corrosion.

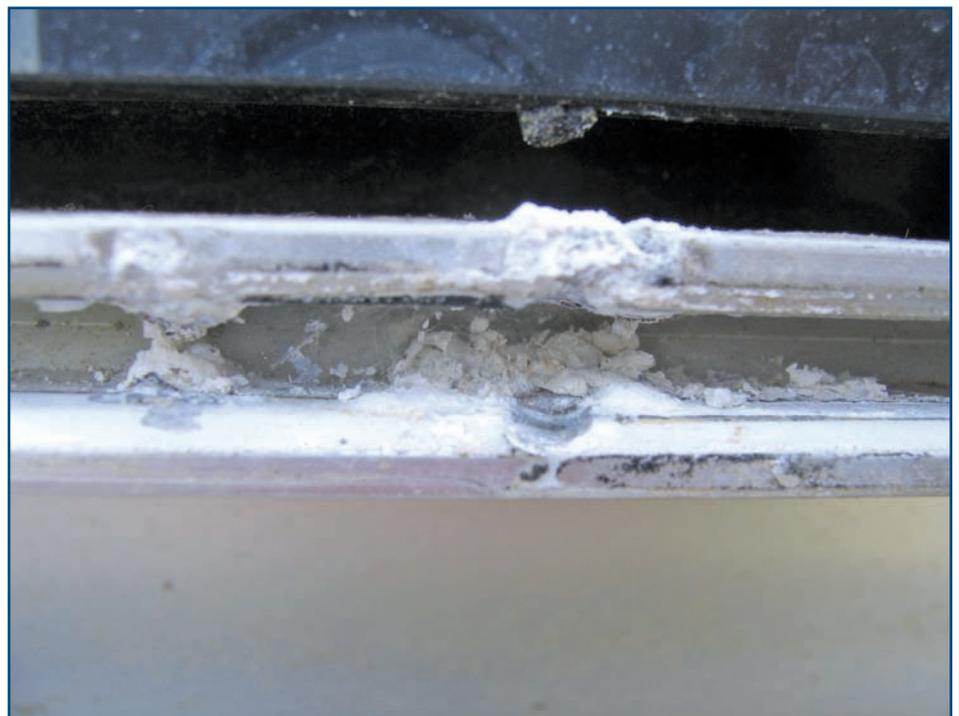
The detrimental effects of galvanic corrosion on the pullout strength of these types of screw connections has been documented by Cui and Schmidt.¹ For severe corrosion conditions, the estimated strength loss after more than 20 years of exposure was approximately 30%. It is widely known that the presence of crevices and a more noble metal can result in severe localized corrosion of a metal that would otherwise remain passive. The horizontal aluminum mullions in this curtain wall system had documented characteristics that promoted corrosion: water infiltration, crevices at the interface between screws and screw chases, and presence of a more noble stainless-steel screw material (as compared to the base aluminum).

Figure 7 – Severe corrosion of aluminum screw chase.

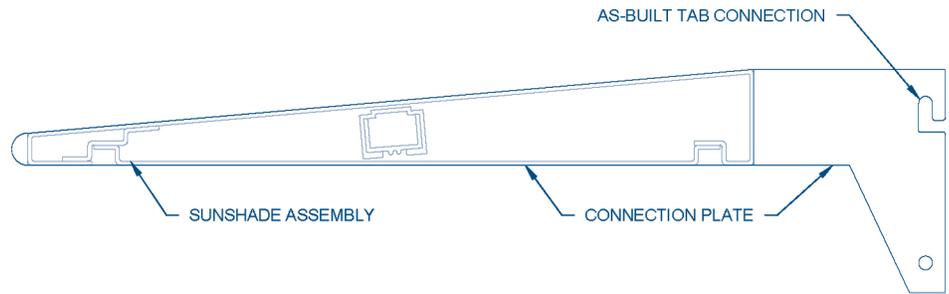
Figure 8 – Geometry of sunshade connection plate as observed in field. Shop drawings indicated top-bolted connection was intended to be a standard hole, not a tab.

extend from the face of the building. The panels are supported by connection plates extending from the building (*Figure 8*). The connection plates are laser-cut aluminum plates that fit into a slot in the vertical mullions of the curtain wall and are connected to the mullion with two vertically spaced bolts. According to the shop drawings, both bolt connections were to be made through standard holes in the plates.

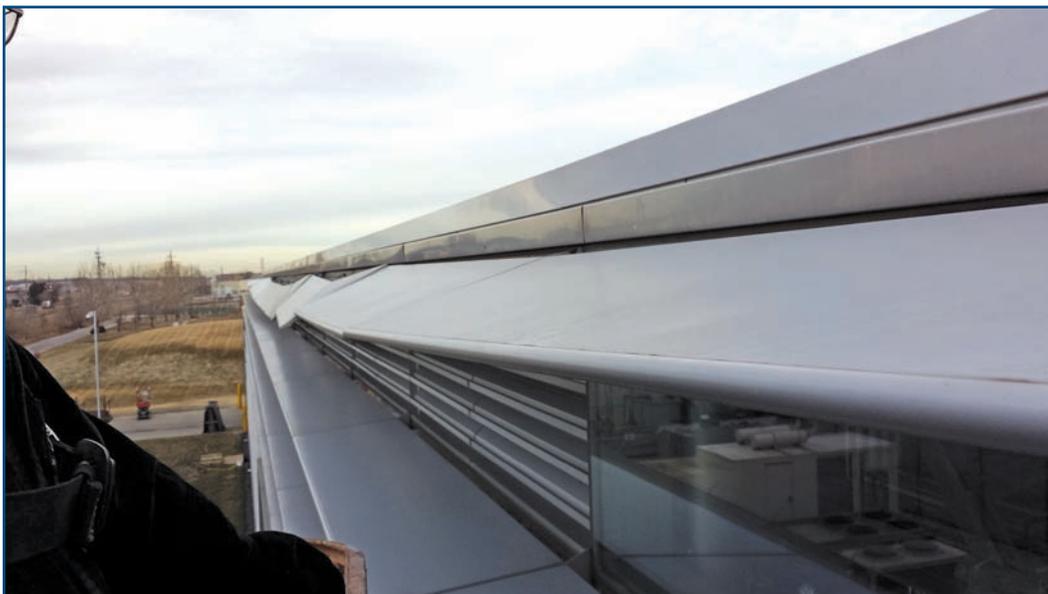
After a large snowstorm during mid-winter, several consecutive panels of the uppermost row of sunshades collapsed (*Figure 9*). Five connection plates were observed to be fractured and rotated out of position. To allow for a more detailed examination

Figure 9 – Failed top row of sunshades.

With the above-described preliminary understanding of the failure mechanism, the sealants at the connection plate-to-building interface were inspected for evidence of movement at all other connections on the same wall. At all top-row connections, at least some stretching and/or tearing of the sealant was observed, indicating movement and possibly early stages of failure at the connections. As a result of these findings, all affected sunshades were immediately removed.

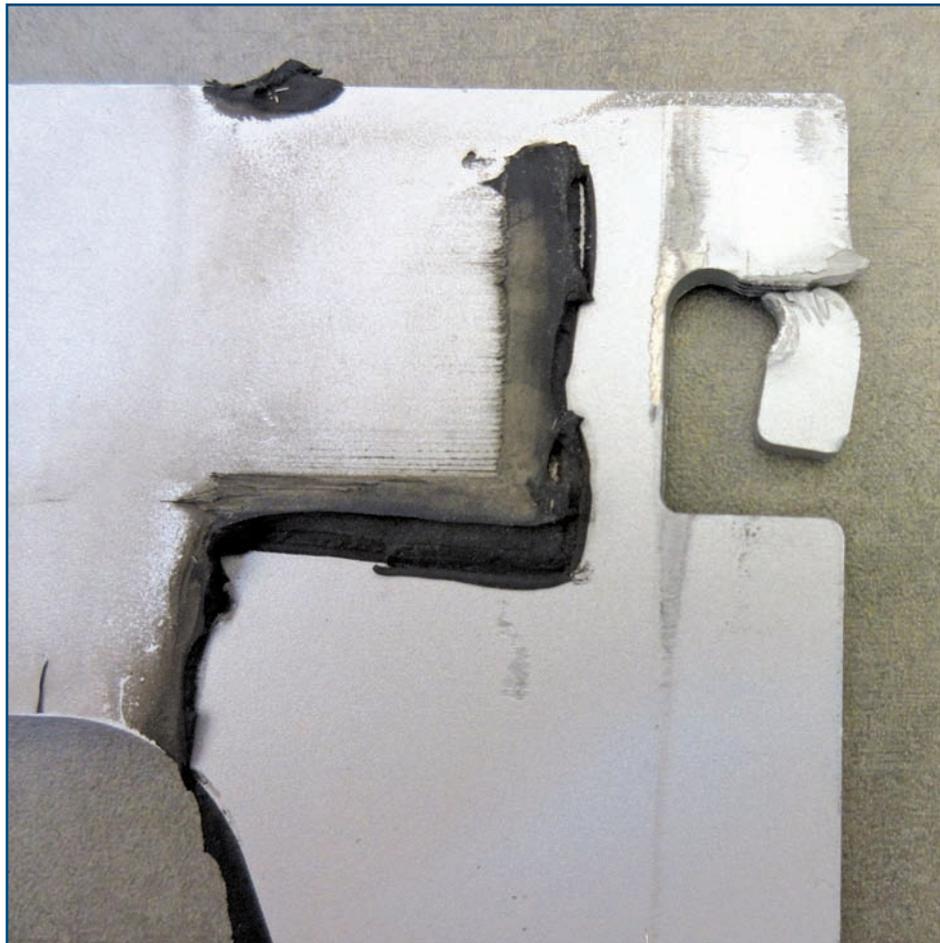
of the connection, a contractor removed two adjacent sunshade panels, as well as the failed connection plate between them. A discrepancy was noted between the shop drawing connection configuration and the installed connections. Rather than a standard hole at the top of the connection plate where it bolted into the mullion (as indicated in the shop drawing detail), a tab-type connection was found, as shown in *Figure 8* and *Figure 10*. At the failed connections, this tab was found to be fractured. This condition may have been a change indicated by the contractor to streamline installation; however, no related documentation was found. Review of such post-design modifications is often overlooked.

Figure 10 – Failed tab connection at top bolt hole of sunshade connection plate.

Only gravity loads were considered for the sunshades, since inclusion of wind loading created a less critical demand. Under combinations of these design loads, structural analysis indicated that the bolted tab connection was grossly overstressed relative to its design capacity at the observed failure plane. Under in-situ loads estimated from weather reports at the presumed time of failure, it was confirmed that the failure of the connection tab was predictable.

As indicated by the shop drawings, the top bolt in the connection plates was originally intended to be installed in a standard hole in the plate. A standard hole would have had a significantly greater shear capacity than the installed tab connection due to an increase in the number of shear planes carrying the load (*Figure 11*). Structural analysis of the as-designed condition indicated that if the connection plate had been fabricated as shown in the shop drawings, it would still have been moderately but not grossly overstressed under applied design loads. Under estimated in-situ loading, though, it is not likely that the connection as shown on the shop drawings

would have failed. It is unknown when the hole-to-tab modification occurred, but it appears likely that the change was not appropriately reviewed; in this situation, a proper review of a design change could have potentially prevented a failure.

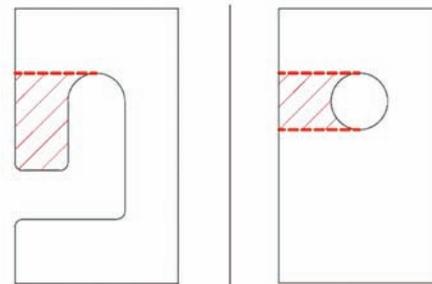
Figure 11 – Shear planes for tab and standard hole-connection details.
