LOW-SLOPE ROOFS ARE ROTTING

By Dwight D. Benoy, PE, and Pamela Jergenson, CCS, CCA

Low-slope roofs are rotting, resulting in major repair costs. Recently investigated roofs on three multifamily residential buildings had failed prematurely. All three buildings were less than ten years old and were located in a northern climate.

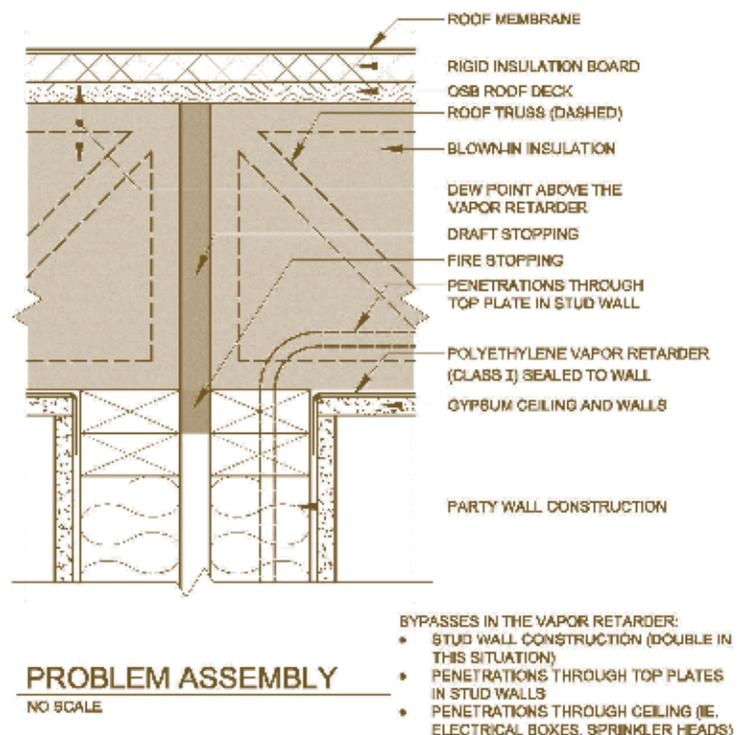
These buildings had similar nonventilated, low-slope roof assemblies utilizing wood trusses with a polyethylene vapor retarder on the bottom of the trusses covered with a gypsum ceiling. Blown-in fiberglass or cellulose insulation filled the truss space from the ceiling to the bottom of the roof deck. Oriented strand board (OSB) of ½-in. thickness was installed over the trusses as the roof deck. Rigid board insulation was installed over the OSB, followed by the roof membrane, which was a gravel-surfaced, built-up roof in one case; a ballasted EPDM single-ply membrane on another; and a mechanically fastened TPO single-ply membrane on the third (*Figure 1*).

Figure 1 – Problem assembly.

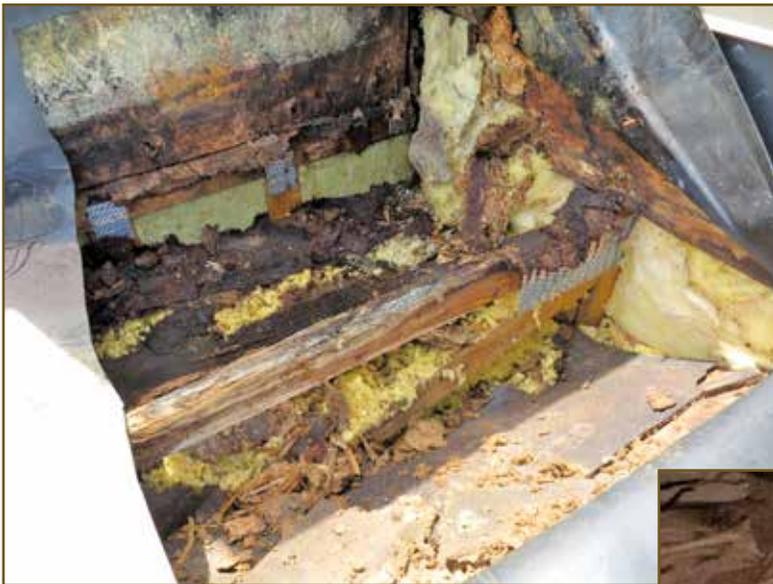
Invasive inspection openings made into the roof assembly revealed the OSB decking was severely deteriorated in many areas, such that it could not support the roofing materials above. The top portion of the top cord of the wood trusses was also wet and rotted in some cases. The steel tie plates of the trusses were corroded. Framing lumber at the exterior walls in the truss space was also wet.

Figure 2 – Rotted deck collapsed into truss space revealing rotted top chord of truss and corroded tie plates.

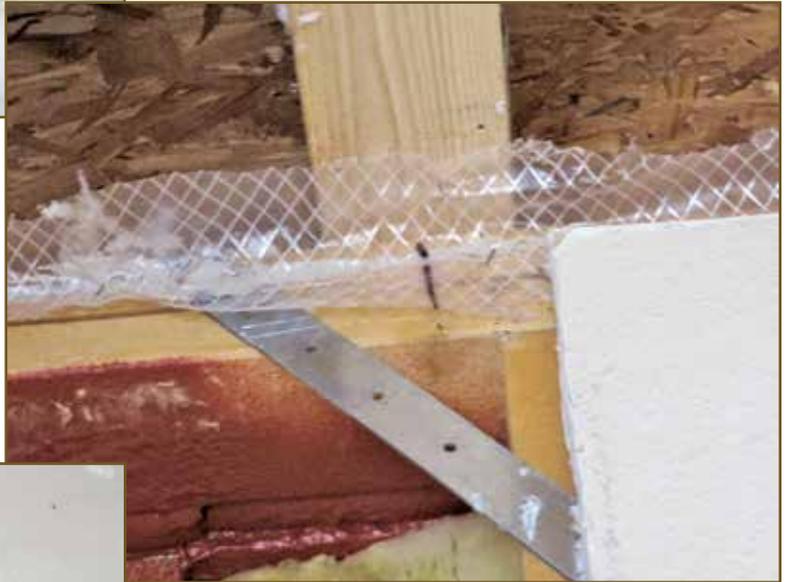
Figure 3 – Vapor retarder bypass at partition and party walls.

The investigations found many bypasses in the vapor retarder that would allow the warm, moist interior air to migrate into the truss space (Figures 2-5). The party walls between apartment units, which were a double-stud wall

construction, interrupted the continuity of the vapor retarder.

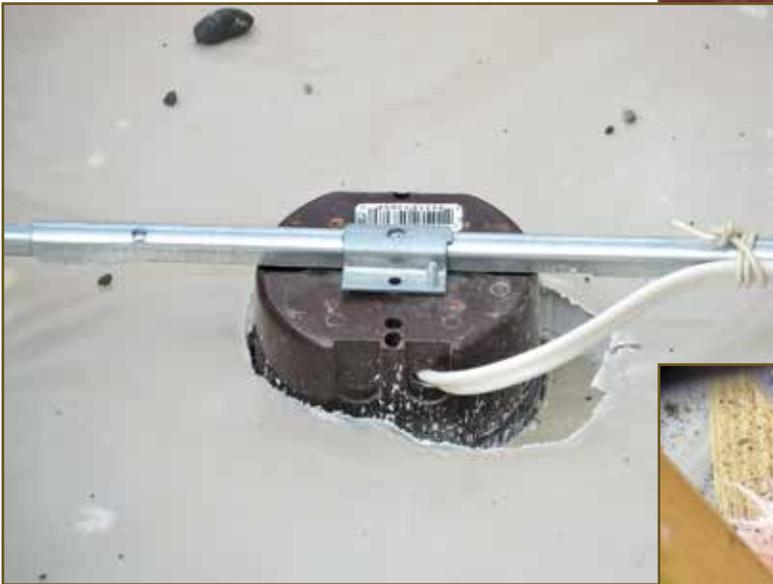
Figure 4 – Vapor retarder bypass at ceiling light electrical box.

Likewise, any interior partition walls resulted in a discontinuity in the vapor retarder at the ceiling. This was exacerbated by the penetrations through the top plate of the wall by plumbing stacks and wiring. Penetrations through the ceiling, such as sprinkler heads and electrical boxes for light fixtures, were also found not to be sealed to the vapor retarder.

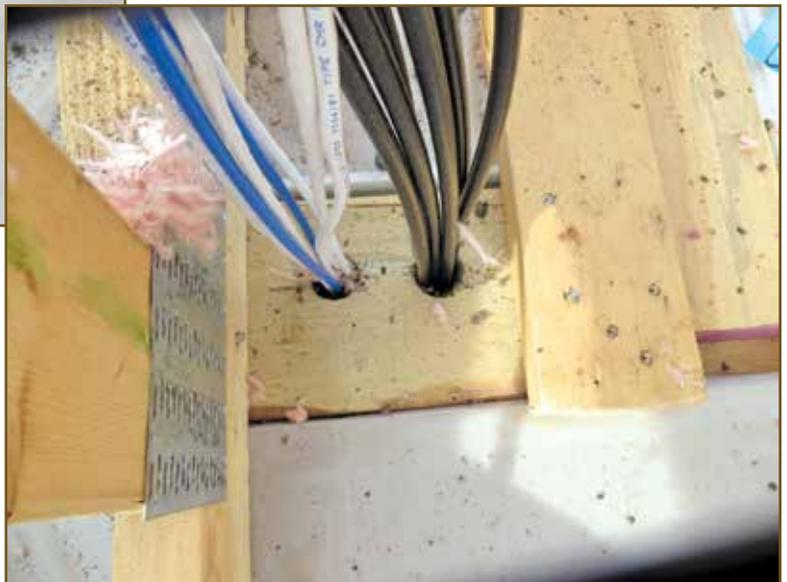
Figure 5 – Vapor retarder bypass through top plate of partition wall.

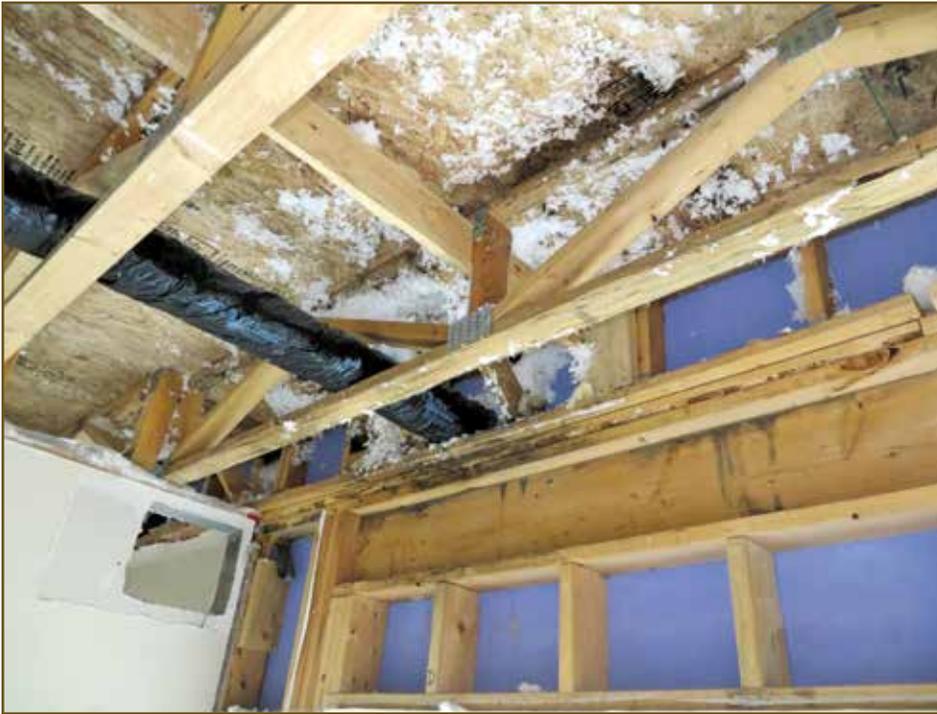
Figure 6 – Leaky dryer and bathroom vent ducts in truss space.

Two of the buildings had ducts from bathroom and dryer vents running through the truss space (Figure 6). Some of these ducts were not well sealed at the joints, which introduced very moist air directly into the space where condensation was most likely to occur.

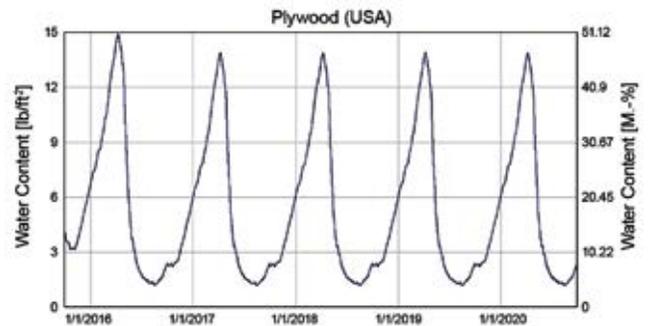
Figure 7 – Hygrothermal model graph of the roof deck in the roof assembly shown in Figure 1.

Figure 7 is the hygrothermal model graph of the roof deck in the roof assembly shown in Figure 1, assuming the presence of vapor retarder bypasses, over a five-year period. The water content of the roof deck exceeds 19% for about 40% of the year, peaking in April. Calculating the dew point using traditional methods by selecting temperature and humidity conditions in January may not have shown the potential problem of excessive moisture in the system that peaks in April. The moisture damage to the roof deck, as observed in the field, strongly correlates to the hygrothermal model results.

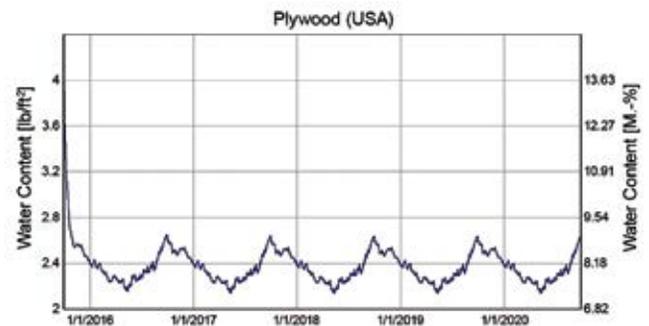
Figure 9 – Hygrothermal model graph of the plywood roof deck in the roof assembly shown in Figure 8.

Figure 9 is the hygrothermal model graph of the plywood roof deck in the roof assembly shown in Figure 8. This shows the moisture content of the plywood roof deck staying below 19% and actually drying out over time from its initial peak moisture con-
