# Field Performance of Spray Polyurethane Foam Flashings

By René M. Dupuis

In September of 2003, The National Roofing Foundation completed its second field study of Spray Polyurethane Foam (SPF) roofing systems. The study, which began in 2001, examined 188 SPF roofs of various sizes and shapes. The roofs ranged in age from new to 31 years, with an average age of 11.75 years.

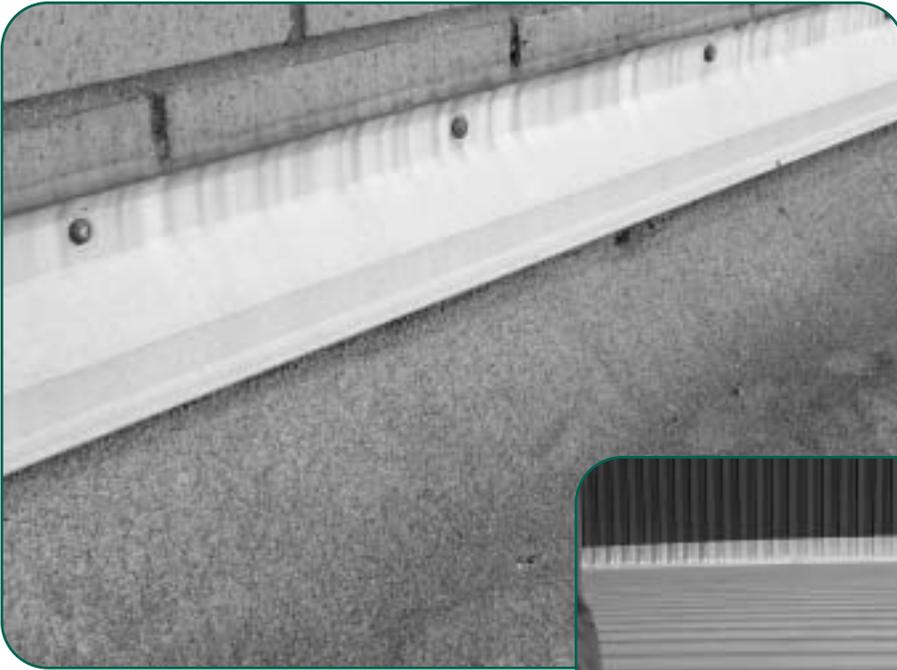
Left: Figure 1 - Standard metal counterflashing.

Figure 1 shows a typical wall with SPF and coating applied up the wall and covered by the metal counterflashing. Galvanized sheet metal was formed and surface mounted with a drip edge. The use of metal as a counterflashing is consistent with detail SPF-4, which can be found in the 5th Edition of the NRCA *Roofing and Waterproofing Manual*.

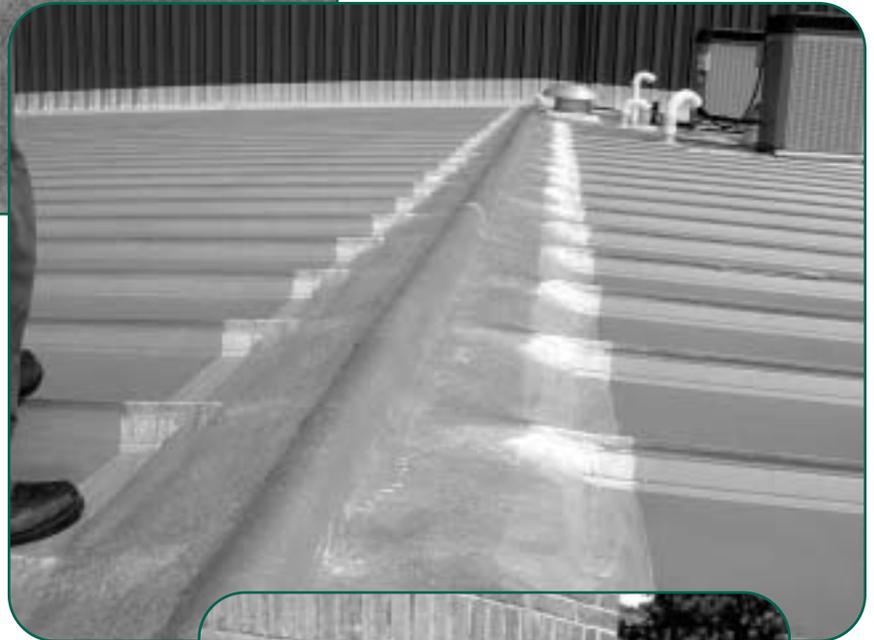
Below: Figure 2 - Metal roof expansion joint.

Figure 2 shows how SPF flashing can be used with a flexible bellows to handle differential and cumulative movement in a large metal roof. Note that the elastomeric bellows has been anchored in SPF and coated. This deck runs along a second-story wall that uses SPF as a transition between roof and wall.

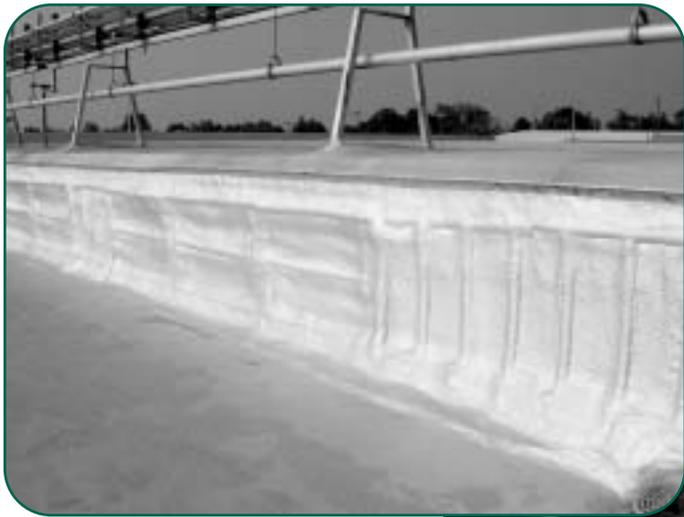
Above: Figure 4 - SPF roof to high roof transition.

A roof-to-roof transition is shown in Figure 4 that details how SPF was used to solve a difficult tie-in for two different roof systems. The existing metal flashing was covered with spray foam and coated. The SPF transition detail also covers a short wall that has metal panels and window units. The SPF tie-in was installed in 1991.

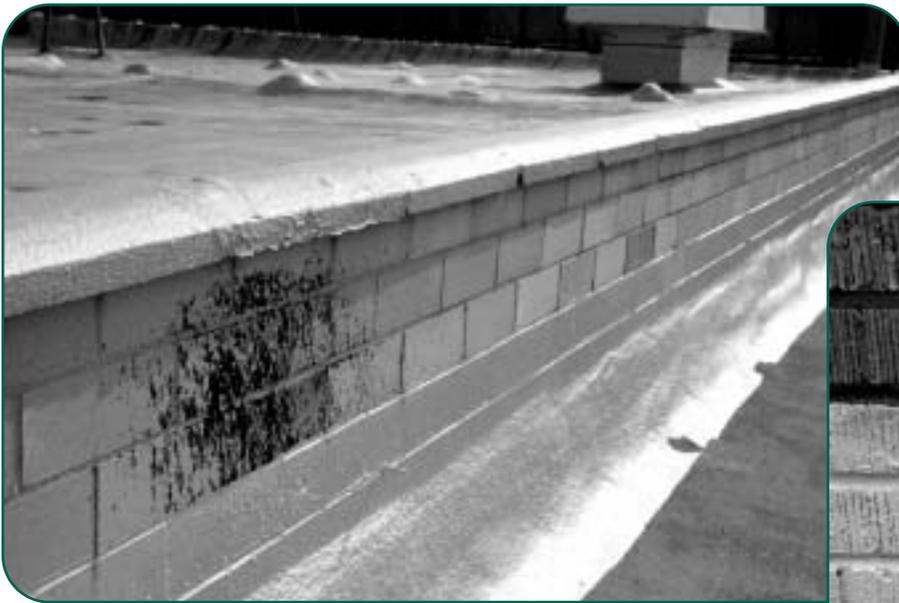
A complete roof and wall transition with SPF is shown in Figure 6. No metal flashing has been used on this 1997 installation. All of the pre-existing metal flashing is now encased in SPF. No new metal was used.

Left: Figure 6 - SPF roof and wall transition.

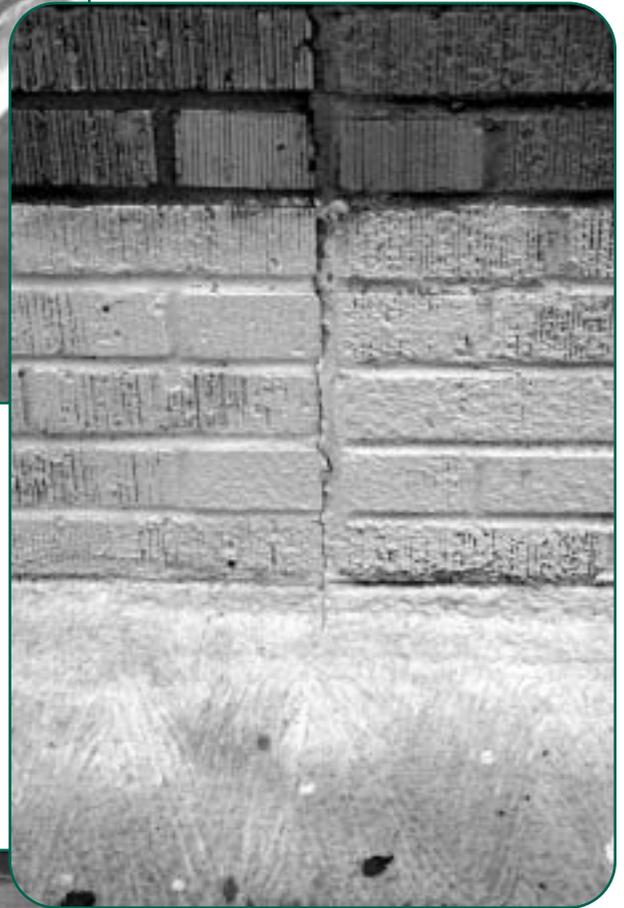
The large lower main roof of this distribution center is broken up by a three-story brick wall. As seen in Figure 7, the expansion joint in the brick wall is active. The SPF re-roof covers all pre-existing metal flashing. The SPF flashing now reaches above the original metal counter flashing. There are no cracks or spalling of the SPF. The coating is functioning as a counterflashing over the SPF at the top of the pre-existing metal.

Below: Figure 7 - SPF wall flashing.

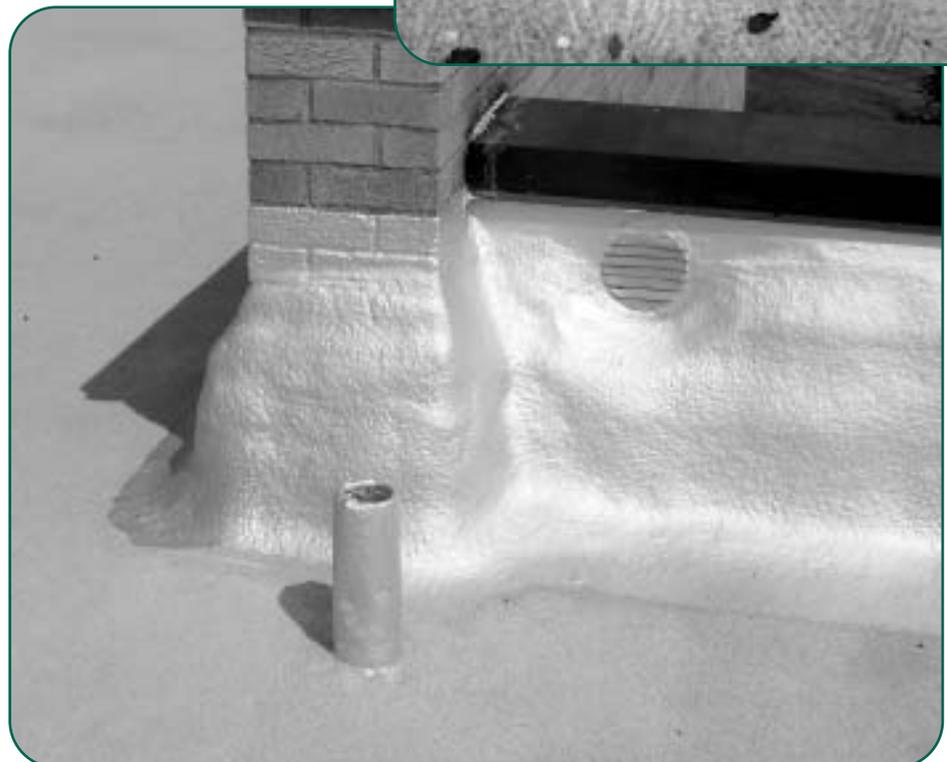
In some instances, walls may be completely covered by the SPF system with no adverse performance. Figure 8 shows a low masonry parapet wall and metal cap system with SPF and coating in a 1998 installation. Wall construction – especially how moisture is handled from the outside brick veneer – must be thoroughly understood before covering with SPF.

Figure 8 - SPF low wall flashing application.

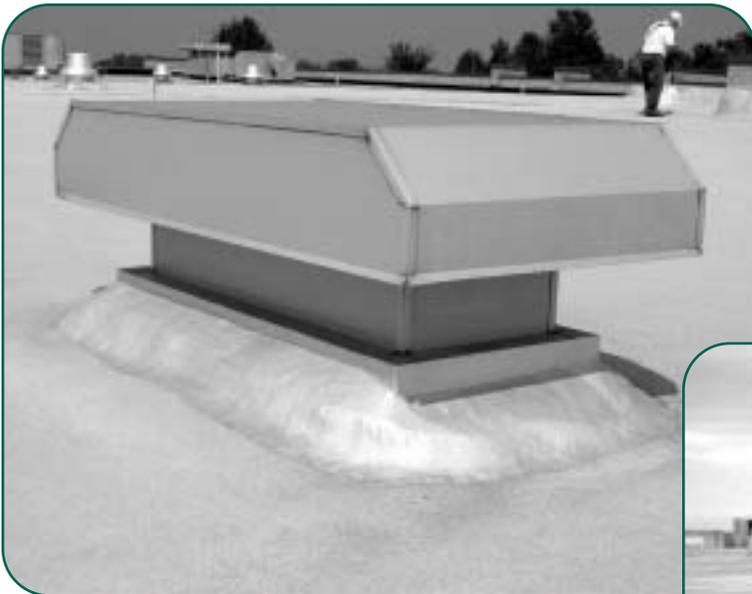
Both low and high equipment support curbs were observed as shown in Figures 9 and 10. The high curb appears to have been extended up with a slightly smaller curb from the original base (Figure 9) and flashed with SPF and coating. Low curbs (Figure 10) were observed to have been treated the same way with no functional difference, using SPF and coating. No metal counterflashing was used, nor does it appear to be needed.

Figure 9 - Equipment support – high curb.

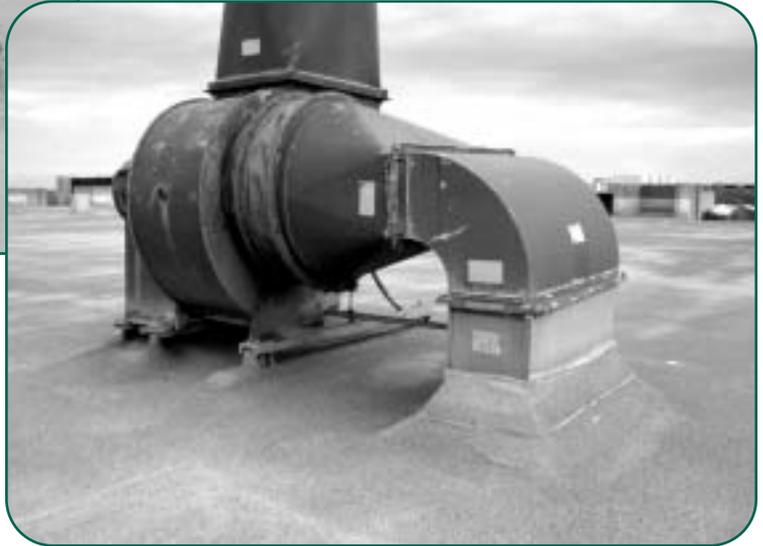
Figure 10 - Equipment support – low curb.

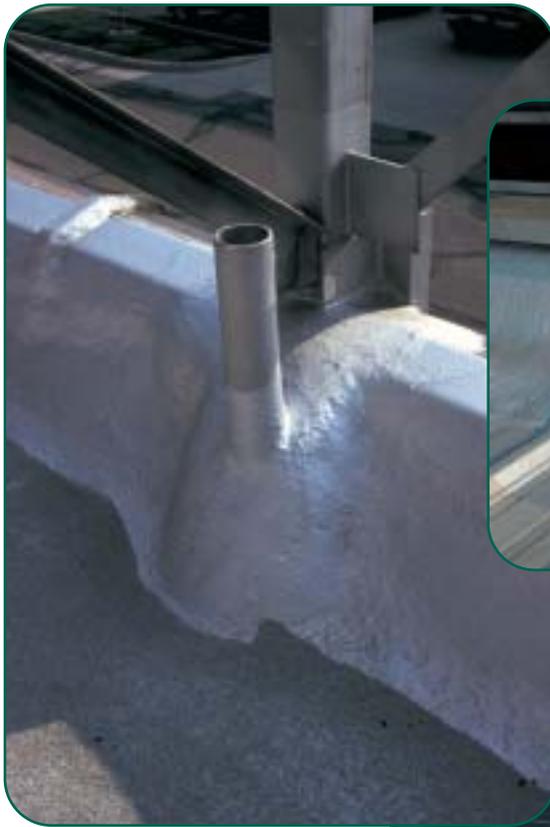
SPF roofs were often found to have no need for pitch pans or for separating support columns that are structurally sound and tied to a wall. *Figure 11* shows a heavy steel support stand that is directly flashed with spray foam and coating into the SPF roof/wall detail. The 1992 flashing installation detail appears to be watertight and serving its intended purpose.

Figure 11 - Equipment support with columns.

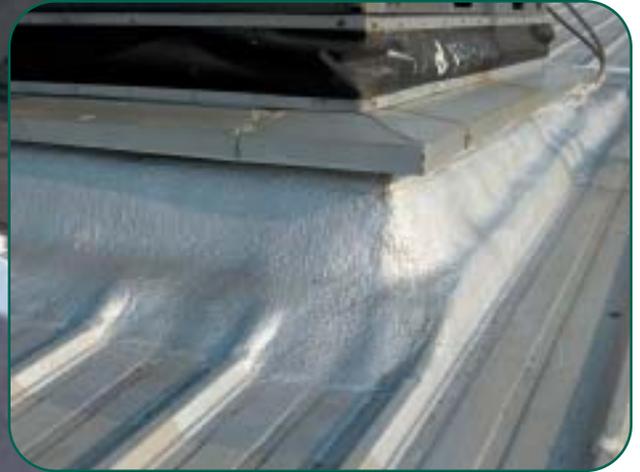
The NRF studies observed numerous flashing details where pre-existing metal flashing had been installed. As shown in *Figures 12* and *13*, SPF can easily adapt to many rooftop details by being overlaid onto the existing prepared substrate. Existing metal flashings may remain and be totally enclosed or left open as the need dictates.

Above: Figure 12 - SPF flashing on a metal roof.

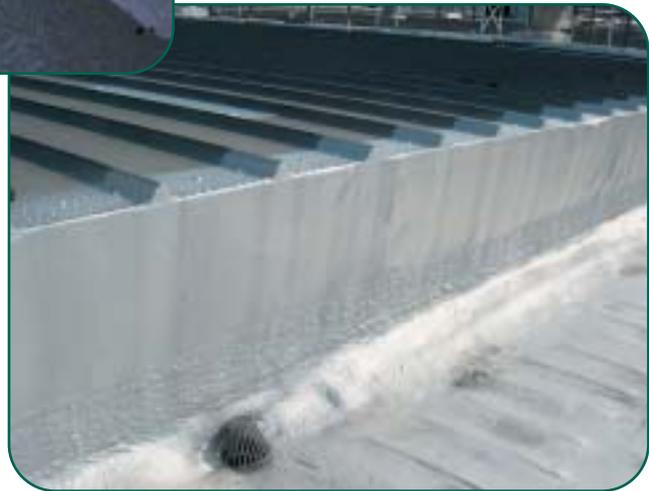
Figure 13 - SPF flashing, roof-to-wall.
