BUILDING ENVELOPE  
TECHNOLOGY  
SYMPOSIUM

**RAINSCREEN WALLS: LONG-TERM PERFORMANCE AND  
FIELD MONITORING IN COASTAL BRITISH COLUMBIA**

**GRAHAM FINCH; BRIAN HUBBS, PENG;  
AND MARCUS J. DELL, PENG**

*RDH BUILDING ENGINEERING INC., VANCOUVER, BC*

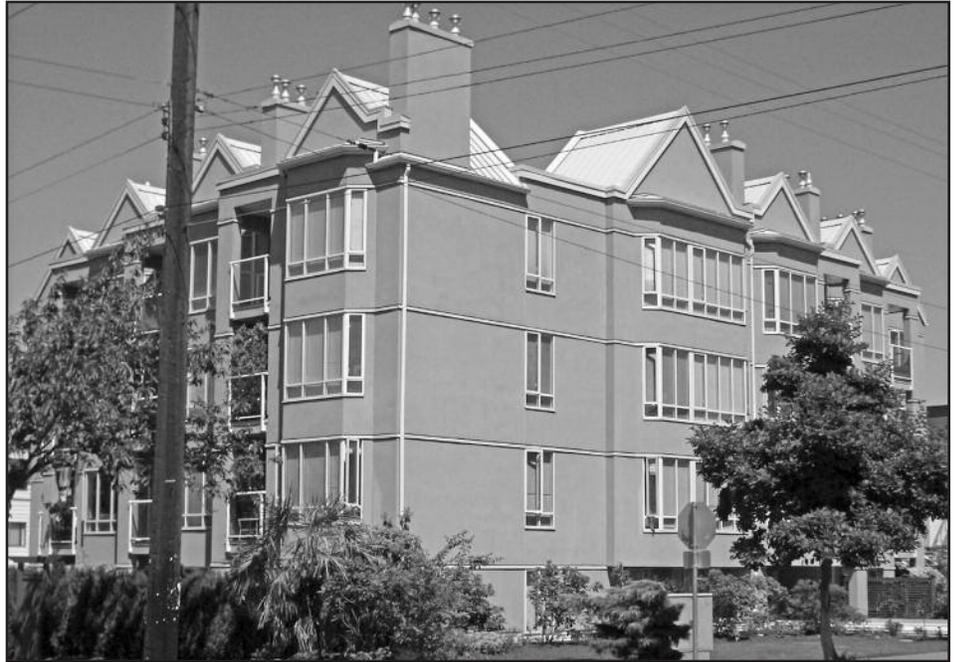
**Figure 1 – Building 2 of the monitoring study overview: a typical four-story, low-rise structure with rainscreen walls.**

This paper presents some of the key findings from the monitoring program for both rainscreen walls and overall building performance. (See *Figure 1*.)

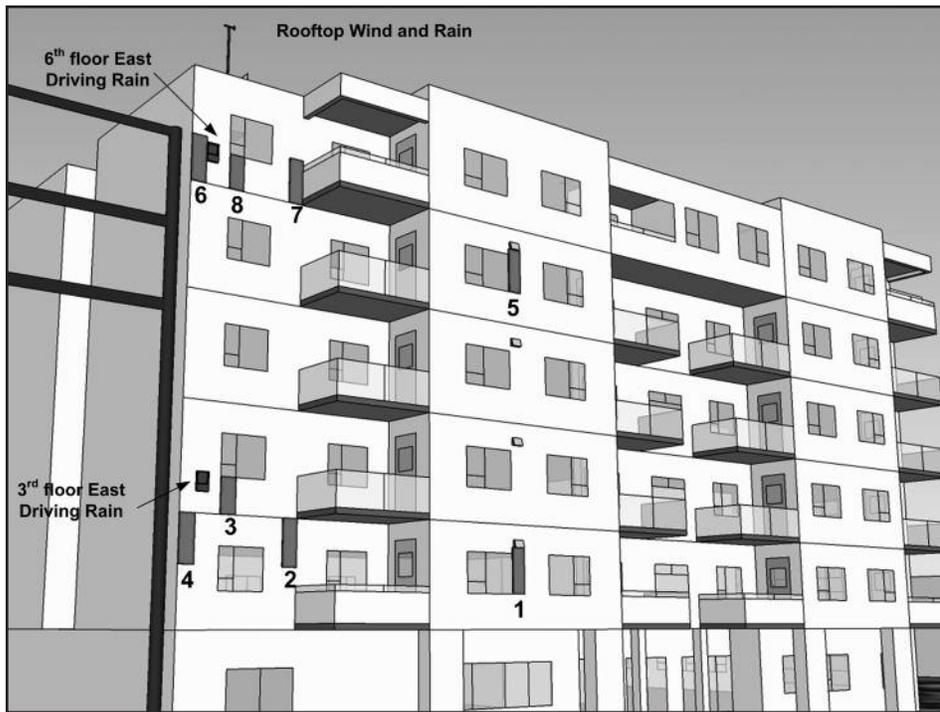
The majority of the monitored locations were chosen to be representative of areas most likely to be wetted during severe weather, while a single location was located in the center of the wall, away from openings or penetrations, to act as a control. The monitored locations were generally chosen on the east and south elevations at key details such as vents, windows, balcony transitions, and saddle flashings where historically high moisture levels have been observed. *Figure 2* shows the monitored locations at Building 3. Other buildings are similar.

**Figure 2 - Building 3 of the monitoring study, location of monitored walls and sensors.**

floors received more driving rain than the lower floors (as seen in Building 3, *Figure 2*), as did the taller buildings. Further information and analysis of the measured driving-rain loads and building geometric effects are provided by Finch (2007).

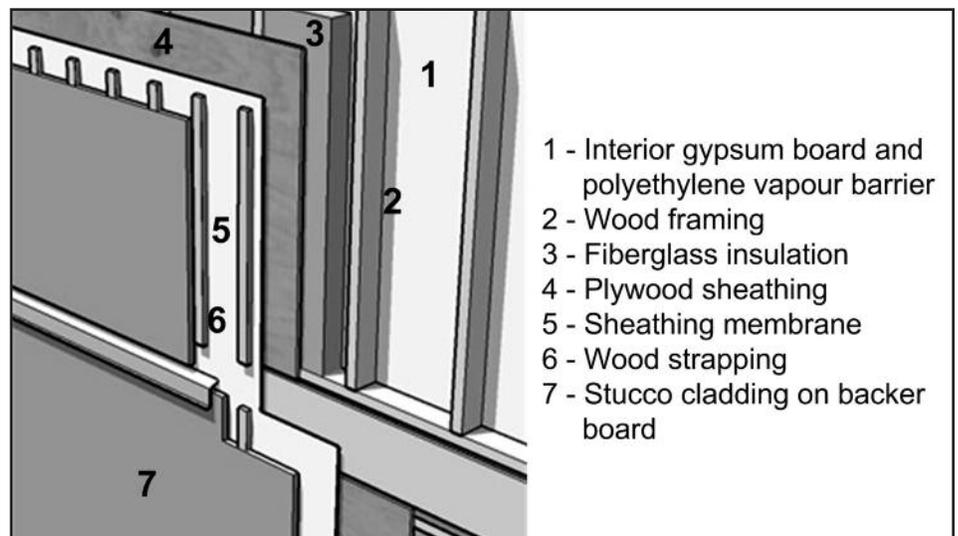
**Figure 3 - Typical residential wood-frame rainscreen wall assembly.**

Data from six years of field monitoring across five different buildings show that rainscreen walls are generally working well in Vancouver's coastal climate. Seasonal moisture levels in wood and gypsum materials, most sensitive to moisture damage, remain below safe thresholds. However, it was also found that rainscreen walls, like all wall assemblies, are susceptible to damage if exposed to excessive moisture at construction details known to be vulnerable. Insulation placement, ventilation behind the cladding, exterior and interior environments, and detailing all have a large influence on rainscreen wall performance. (See Figure 3.)

The impact of cavity ventilation is shown in Figure 8, comparing conventionally insulated stucco rainscreen walls (Figure 3) with good ventilation, restricted ventilation (vents largely blocked), and no ventilation. The increased moisture content is largely caused by inward vapor drive due to solar radiation without a vented release to the exterior. The data shown are simulated using WUFI, a hygrothermal modeling program, calibrated with measured field data from the monitoring program. As shown, higher ventilation rates are directly related to drier walls. The more driving rain a wall is exposed to, the more critical ventilation issues become.

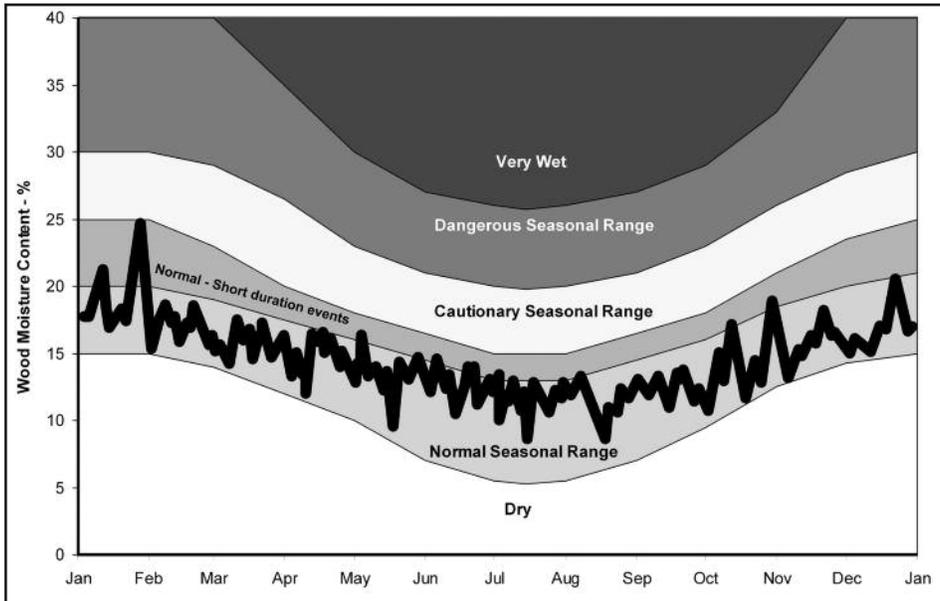
Figure 4 compares typical seasonal moisture content ranges for sheathing within a wood frame rainscreen wall in coastal BC (similar to that in the generic assembly shown previously). The black line plots average measured values from the monitoring study. Normal, cautionary, and dangerous ranges were developed from field measurements and computer modeling based on commonly accepted thresholds for wood products. For example, a moisture content of 20% would be considered normal in February, but if the same measurement was recorded in July, it should be investigated further (Finch 2007).

**Figure 4 – Typical seasonal moisture content ranges expected for wood-frame rainscreen walls.**

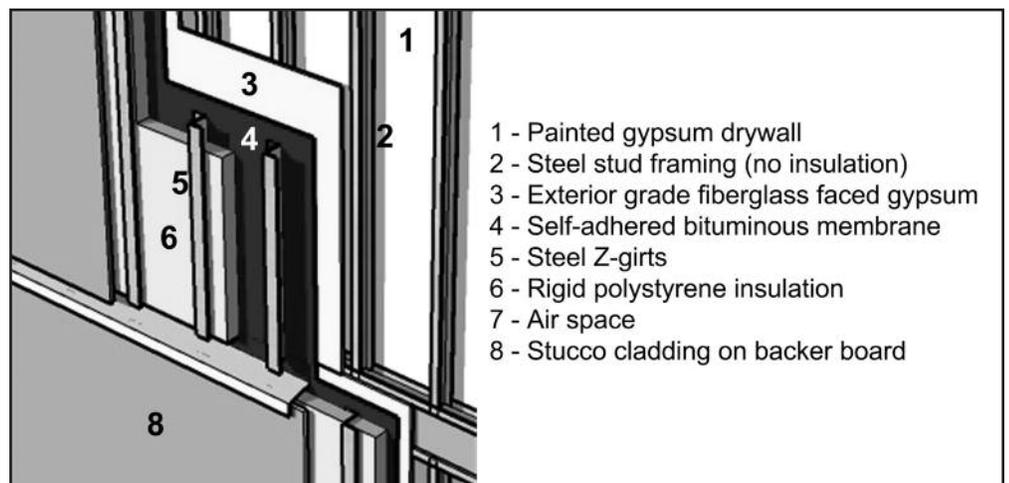
The highly exposed 30-story high-rise building monitored was constructed with an exterior insulated wall assembly. This wall assembly consists of stucco cladding over a ventilated and drained airspace, extruded polystyrene, and a self-adhered air/vapor/water barrier membrane applied directly to fiberglass-faced gypsum sheathing. By putting the insulation outside the sheathing, moisture-sensitive materials are kept warm and dry, close to interior conditions. This rainscreen wall assembly proved most resistant to moisture from driving rain and exterior and interior humidity. All sensors in this building returned dry readings for the entire year. No evidence of exterior moisture penetration or condensation was observed at any of the monitored wall locations. Inward or outward vapor drive is not an issue with this assembly.

Hygrothermal modeling also shows that, in case of small, infrequent leaks past the impermeable air/vapor/water barrier, drying can occur towards the interior when vapor-permeable interior finishes are used. Moisture accumulation and damage is not likely to occur, except in extreme cases of wetting. (See Figure 5.)

**Figure 5 – Exterior insulated assembly at Building 5.**

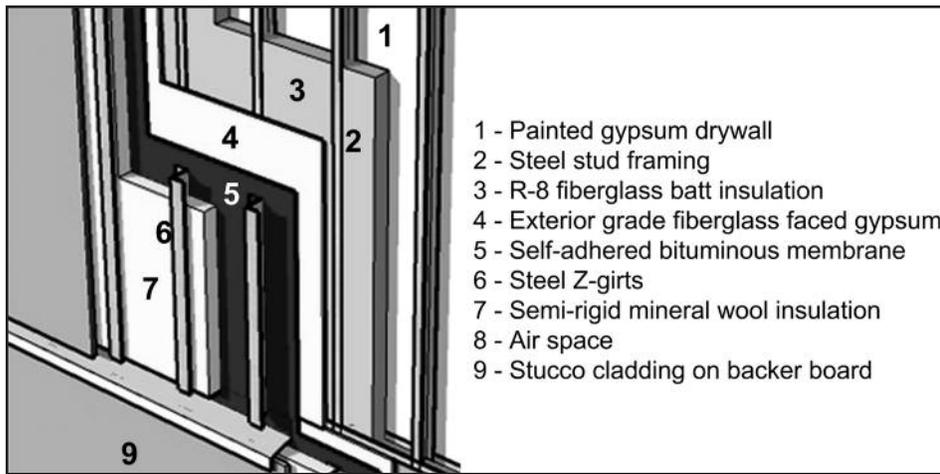
- 1 - Painted gypsum drywall
- 2 - Steel stud framing
- 3 - R-8 fiberglass batt insulation
- 4 - Exterior grade fiberglass faced gypsum
- 5 - Self-adhered bituminous membrane
- 6 - Steel Z-girts
- 7 - Semi-rigid mineral wool insulation
- 8 - Air space
- 9 - Stucco cladding on backer board

Figure 6 - Split insulated assembly from Building 3.

Building 3 of the monitoring study was rehabilitated with a dual insulation wall assembly. The original assembly consisted of face-sealed stucco over an insulated steel stud wall backup. During rehabilitation, the polyethylene sheet was removed, but the existing fiberglass batt insulation in the steel stud cavity was retained. New gypsum sheathing, a self-adhered air/vapor/water barrier membrane, 2 in of mineral wool insulation, and new stucco cladding were added to the exterior walls (Figure 6).

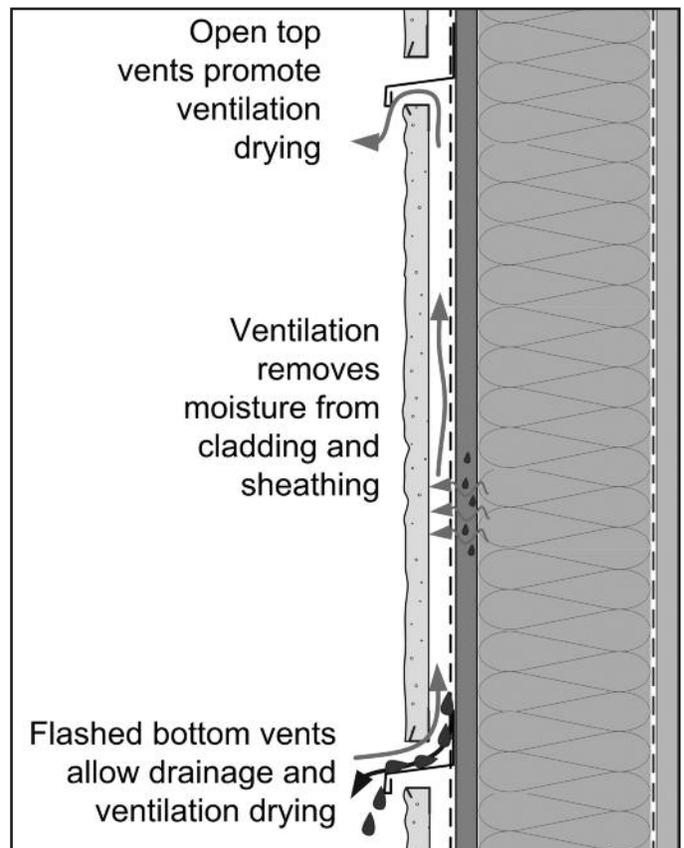
wall assembly. This airspace between the cladding and sheathing membrane effectively increases the durability of both components (Figure 7).

The function of the airspace between cladding and backup construction of a rainscreen assembly is to provide drainage, ventilation, and a capillary break (Figure 7). Drainage removes any bulk water that penetrates past the cladding. However, drainage alone cannot remove small droplets of bound water or water absorbed into the sheathing, strapping, or cladding. Ventilation is shown to have a significant impact on this aspect of performance in rainscreen walls. A 1/2-in to 3/4-in continuous open gap behind the cladding, which is common for most residential construction, is generally sufficient.

Figure 7 - Ventilation and drainage behind the cladding of a rainscreen wall.

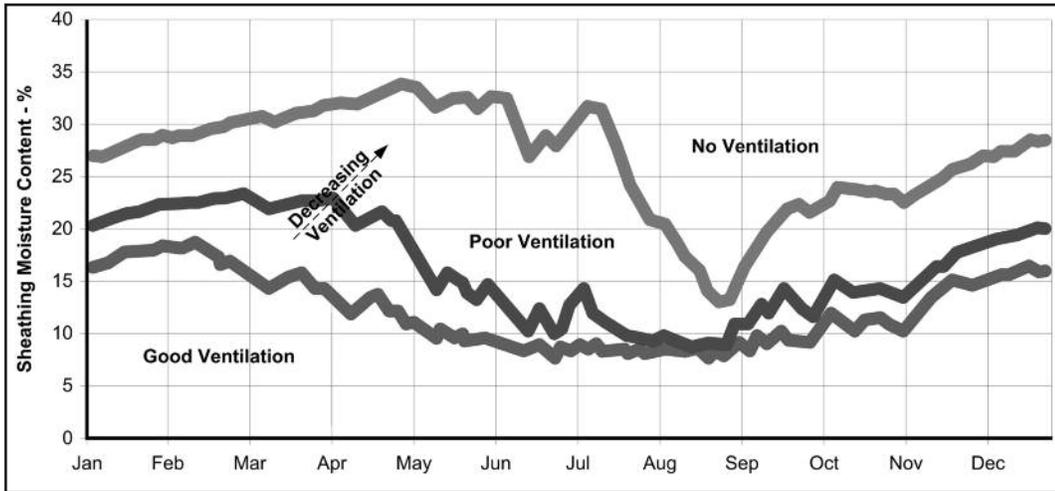
Figure 8 – Impact of ventilation rate behind cladding in rainscreen walls.

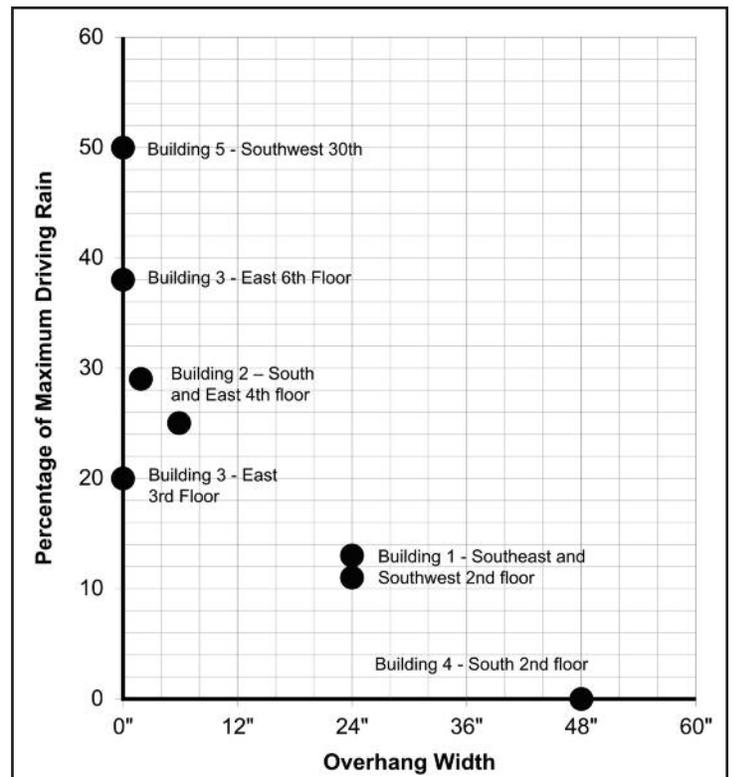
Figure 9 compares the effect of roof overhang width versus driving-rain accumulation for all five monitored buildings. The measured driving rain is compared to the maximum potential driving rain, based on wind speed and direction measured at the roof. As shown, those buildings with large overhangs 24-48 in received significantly less driving rain than those buildings with no overhang or overhangs of less than 12 in. A

48-in overhang on a relatively sheltered four-story building can reduce driving rain on its façade to negligible levels. Upper floors received more driving rain than lower floors; however, increased wetting from water cascading down over the lower wall areas is not shown by this figure.

From the plot of the five buildings, the correlation between overhang width and driving-rain load is shown. Large overhangs are effective at reducing the driving-rain load on a wall by influencing the wind against the wall (Straube 1998). As expected, the monitoring data show that the top

Figure 9 – Plot of overhang width versus percentage of total driving-rain potential.

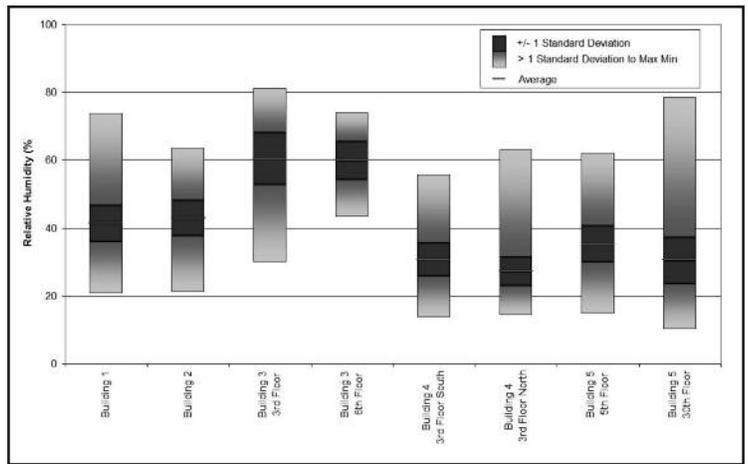
It is also possible to achieve low (<40% average) interior wintertime RH levels in Vancouver's temperate climate, since RH varies with interior moisture generation and building ventilation. Suites that had low wintertime RH levels (between 30 and 40%) had sufficient – and in one case excessive – ventilation rates. High wintertime RH levels (between 50 and 70%) were only observed in Building 3 and were found to be primarily from insufficient suite ventilation. *Figure 10* compares the measured interior relative humidity levels for the five buildings.

**Figure 10 – Interior average wintertime relative humidity, monitored buildings in Vancouver.**

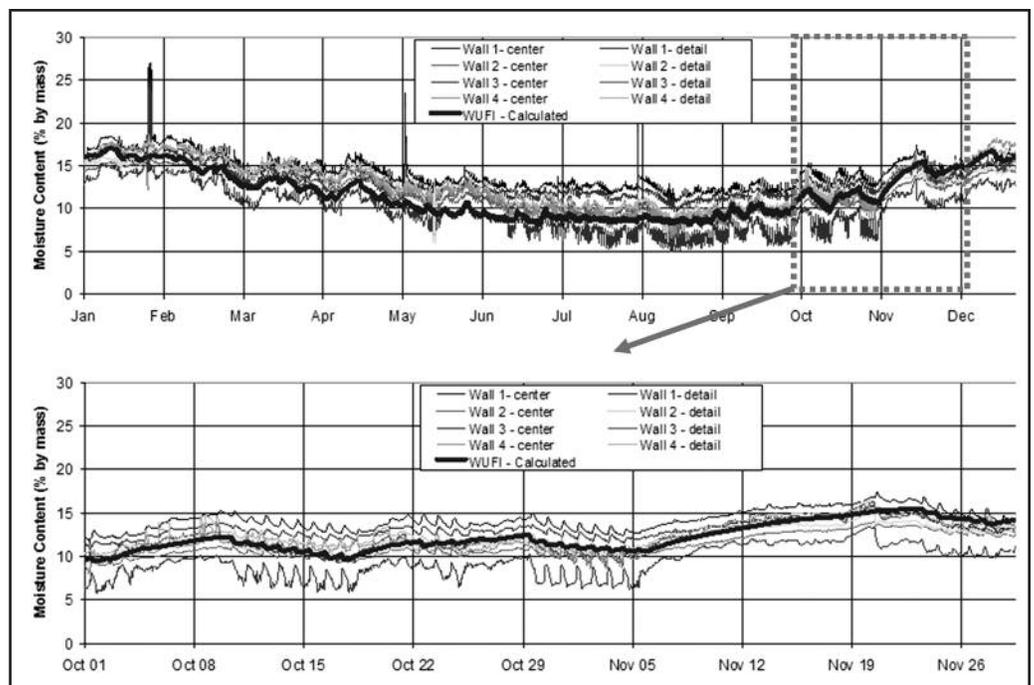
**Figure 11 – Comparison of measured and WUFI simulated moisture content – typical wood frame stucco rainscreen wall.**

collected from site. WUFI was found to be able to predict the performance of each wall assembly with good correlation (Finch *et al.*, 2007; Finch 2007). This provides comfort that this hygrothermal modeling tool is reasonably accurate for performing preliminary design analyses for rainscreen wall assemblies. *Figure 11* compares four different monitored wall locations at Building 1 (wood frame with hard-coat stucco cladding) to modeled WUFI results. Natural variations in the moisture content readings in the measured data are due to differences in sensor location, thermal bridging effects, and the nonhomogenous nature of plywood when measured with electrical resistance. The WUFI results predict moisture contents and trends following the average of these values.

WUFI is a computer program that can model the hygrothermal (moisture and heat) transport within a wall assembly exposed to chosen exterior and interior climatic conditions. WUFI is a powerful design and forensic tool that allows engineers the ability to predict the performance of a wall or roof prior to its design or the ability to simulate a condition leading up to a building problem in forensic applications. This monitoring study provided excellent data for comparison to that simulated in the WUFI 4.1 hygrothermal model.

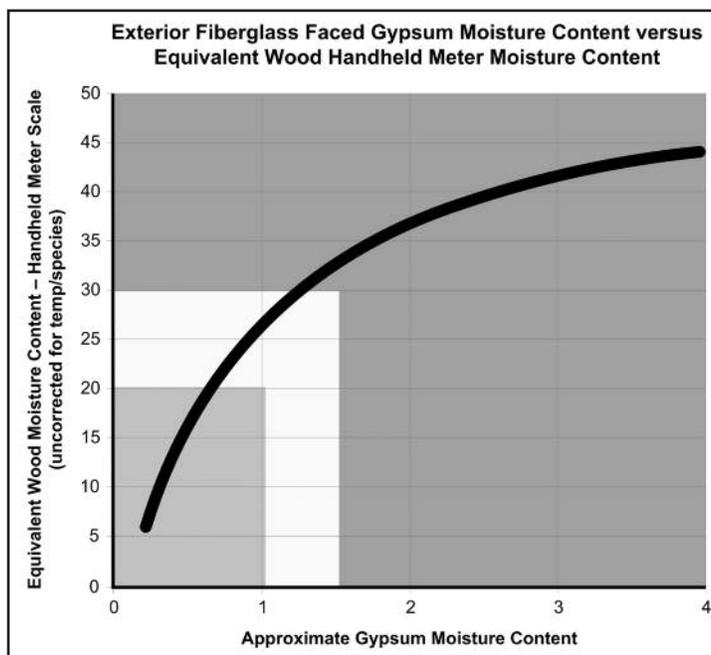
To analyze the moisture content of the buildings constructed with gypsum sheathing, the moisture content of gypsum sheathing was correlated with its electrical resistance, similar to the concept applied to wood-moisture meters. This calibration was correlated one step further so that the moisture content of gypsum sheathing can be approximated with a wood-moisture meter and the correction curve to give an indication of wet or dry conditions and possible risk (*Figure 12*).

**Figure 12 – Wood moisture content scale vs. approximate gypsum moisture content.**
