RETROFITTING STRUCTURAL

COMPOSITE ROOF DECKS

By Lynn Nunley and Dr. Larry Luttrell

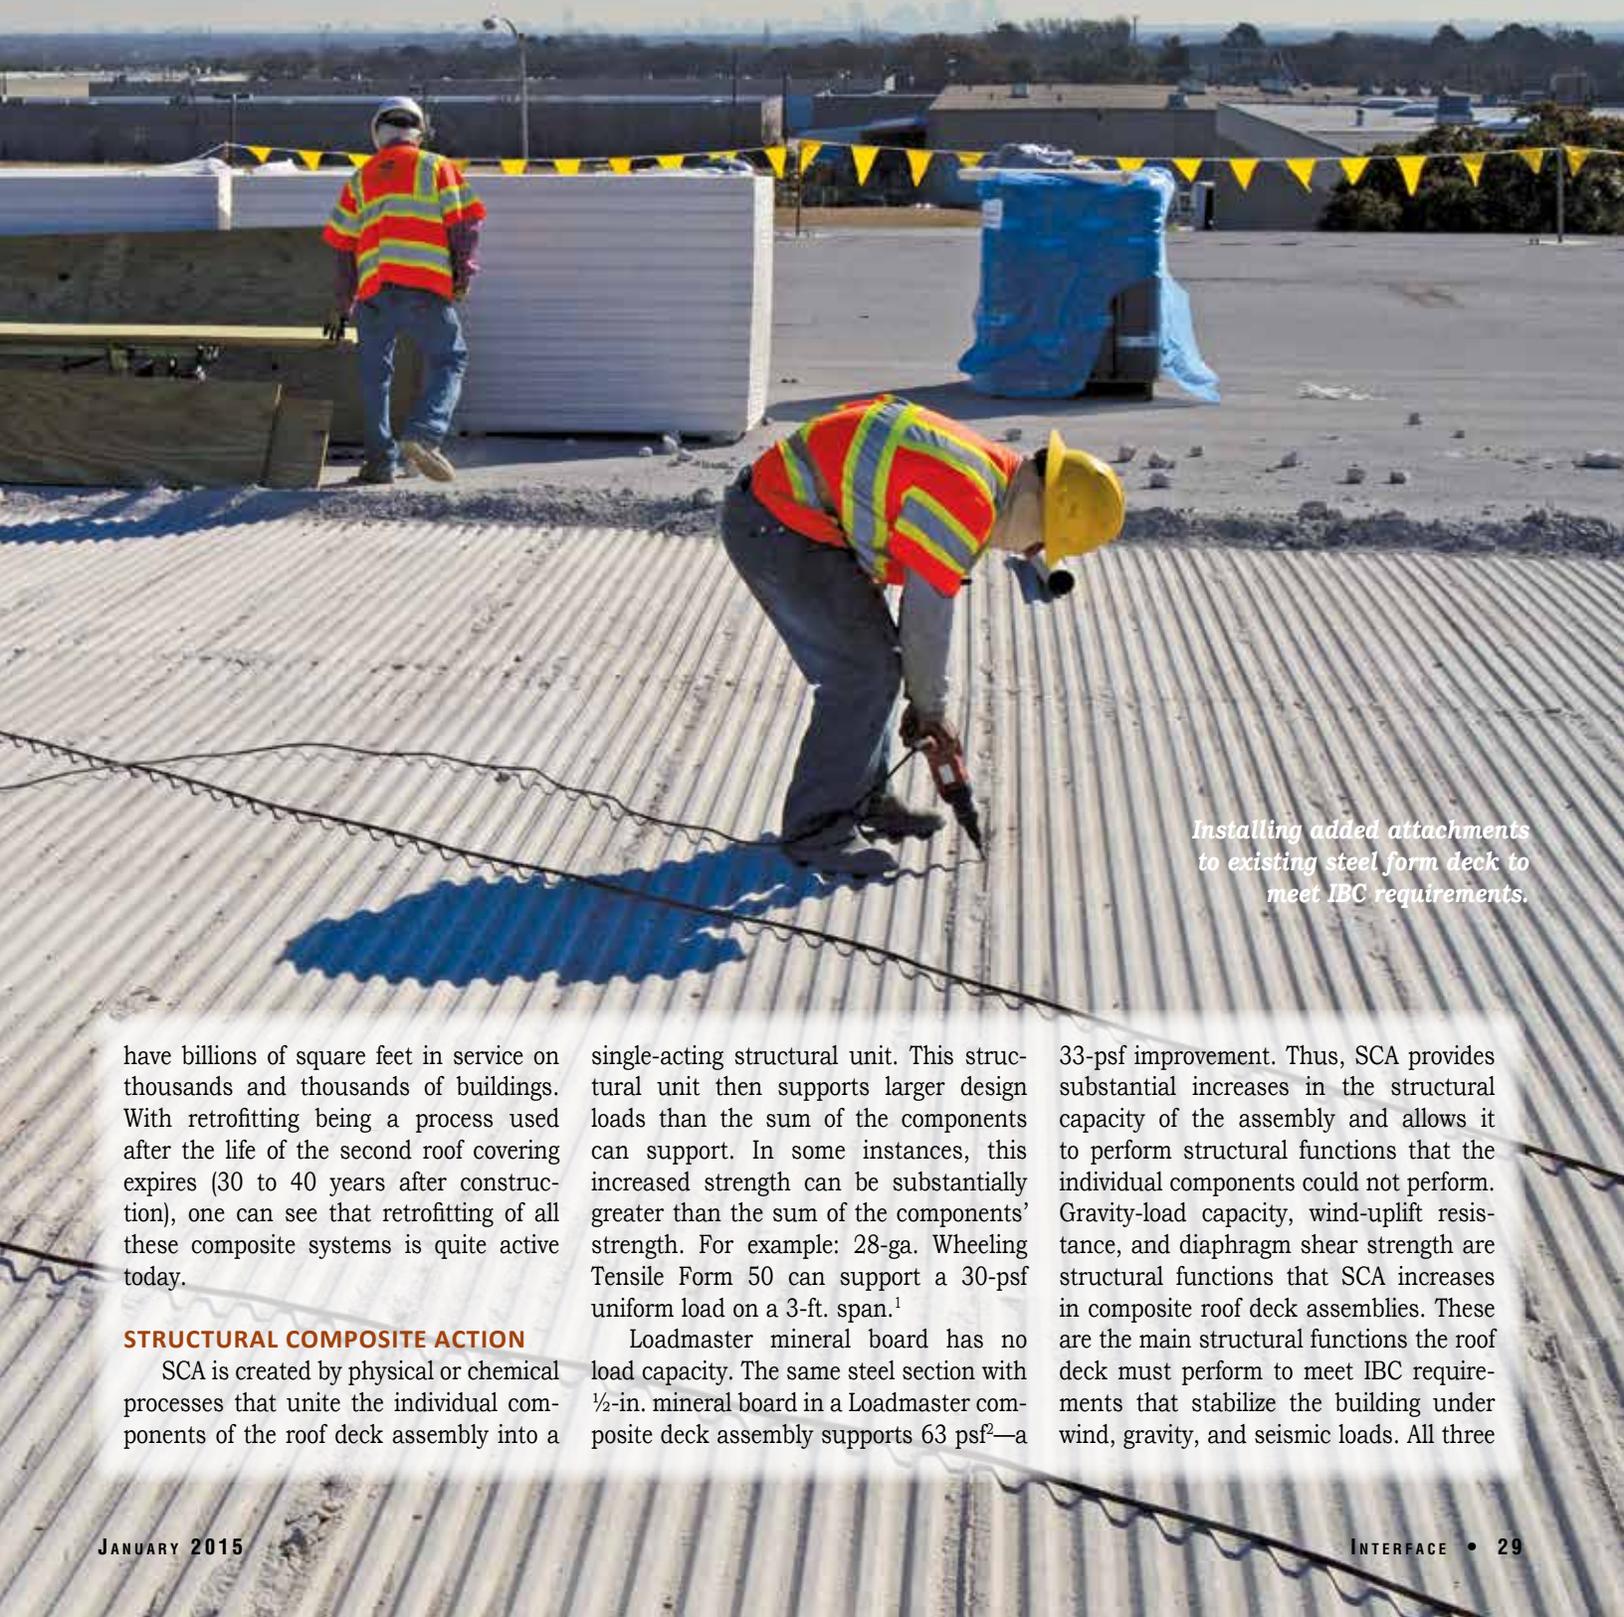
Installing added attachments to existing steel form deck to meet IBC requirements.

form deck with new compatible materials. If the engineering study finds it necessary, update steel form deck attachment to comply with current combined loading requirements. Install water protection in the building below, including protection for ceilings, furniture, carpeting, light fixtures, etc. to protect from free water or flow-through of LWIC that will occur during LWIC replacement. Wire-brush the top of all steel form decking to expose the zinc finish. Remove all dust and loose concrete pieces to present

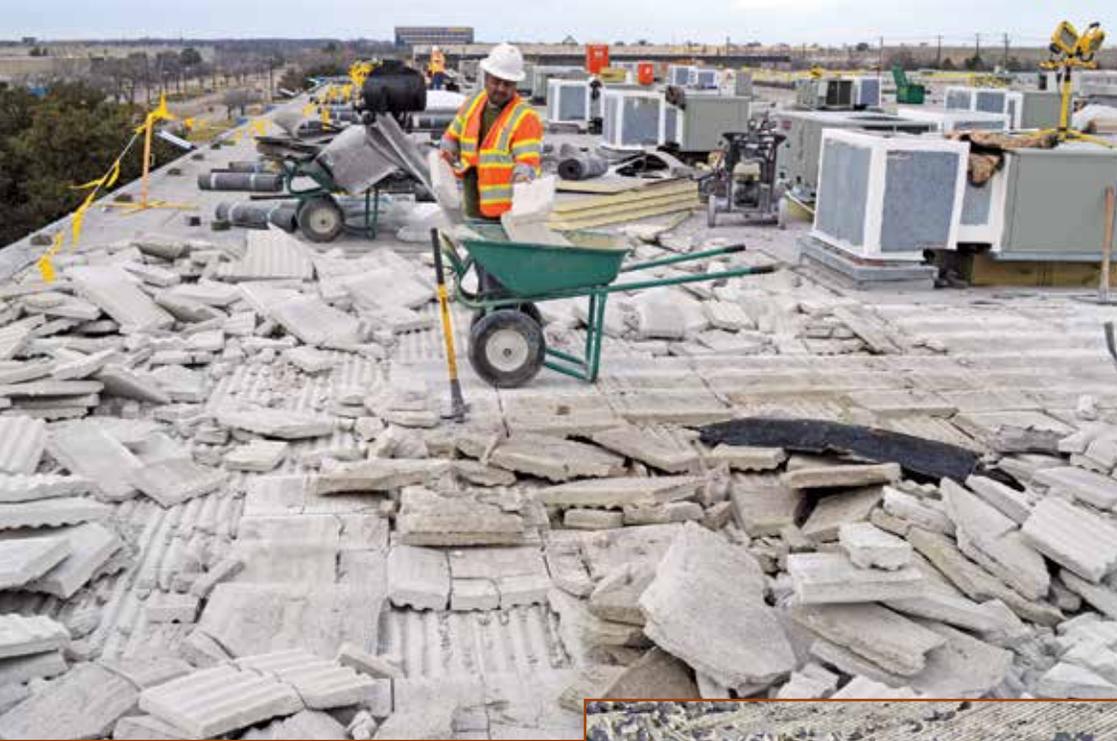
Removal of wind-damaged LWIC from steel form deck.

Option No. 1: Replace the LWIC with new LWIC. If the damage to the LWIC was from wind loads (and most substantial structural damage to LWIC is from wind loads), the IBC requires a sealed evaluation by a licensed design professional⁶ confirming the need for SCA renewal. If engineering studies confirm this to be an acceptable solution, remove the existing roof covering and the LWIC from the steel form deck. Replace any deteriorated or damaged steel

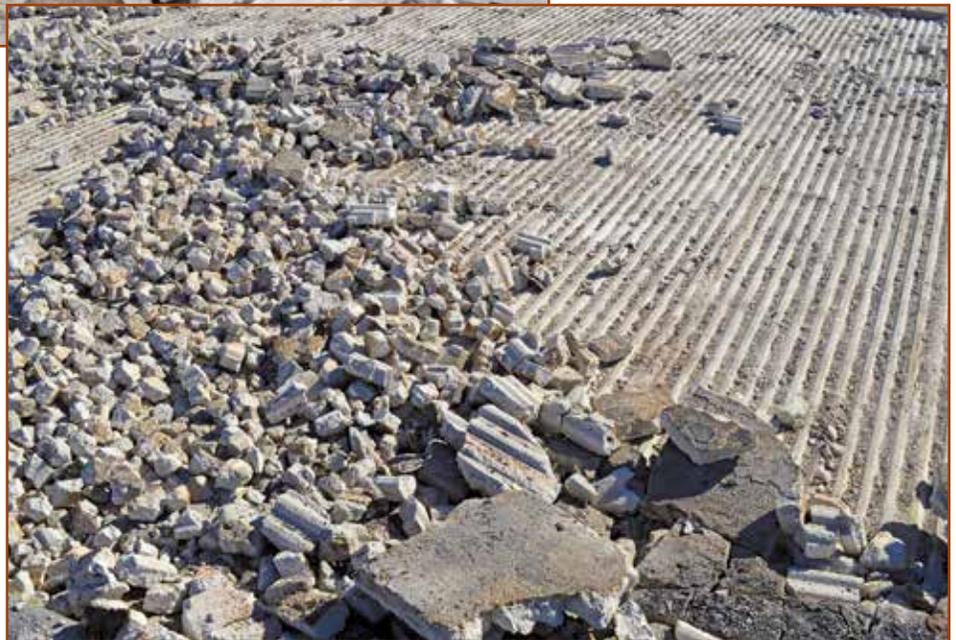
Exposing steel form deck of wind-damaged LWIC roof deck.

Experience has shown that substantial structural damage to the LWIC roof deck that would compromise or destroy the SCA is easy to recognize. If the monolithic slab is broken into small pieces or has lost its bond with the steel form deck, then the SCA has been compromised or destroyed.

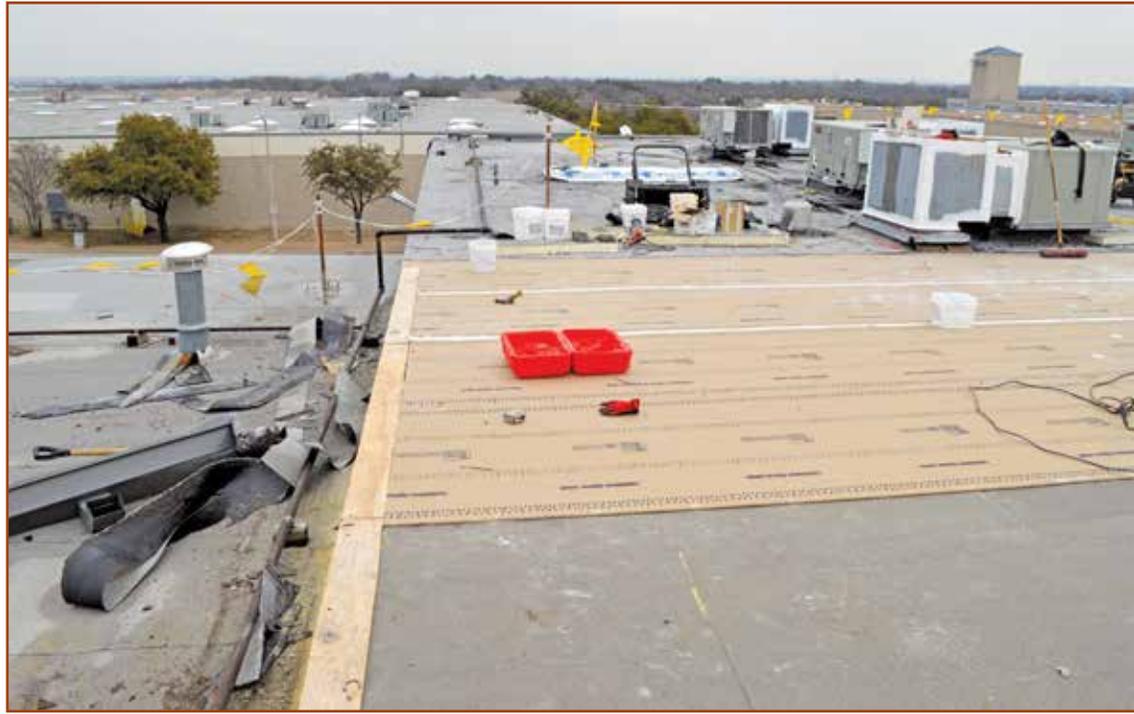
Loadmaster composite components installed over existing steel form deck.

Option No. 2: Remove the roof covering and the LWIC. Convert the existing steel form deck into a Loadmaster composite deck system, creating the required SCA with dry installed board components and engineered screw attachment. After a thorough field inspection, Loadmaster will conduct the wind evaluation as required by IBC and engineer the new SCA to meet the building code requirements. Present the design, sealed by a design professional, to the building code official as required by the IBC and, upon approval, proceed with the installation.

Employ a licensed and trained dealer to remove the LWIC, replace any damaged steel form deck with compatible materials, and install additional attachment of the steel form deck areas as required to bring the SCA in compliance with the required combined design loads. Install optional insulation and the required dense mineral board, all attached with the properly engineered attachment pattern to complete the SCA formation. Install the new roof covering daily to keep the building in the dry.

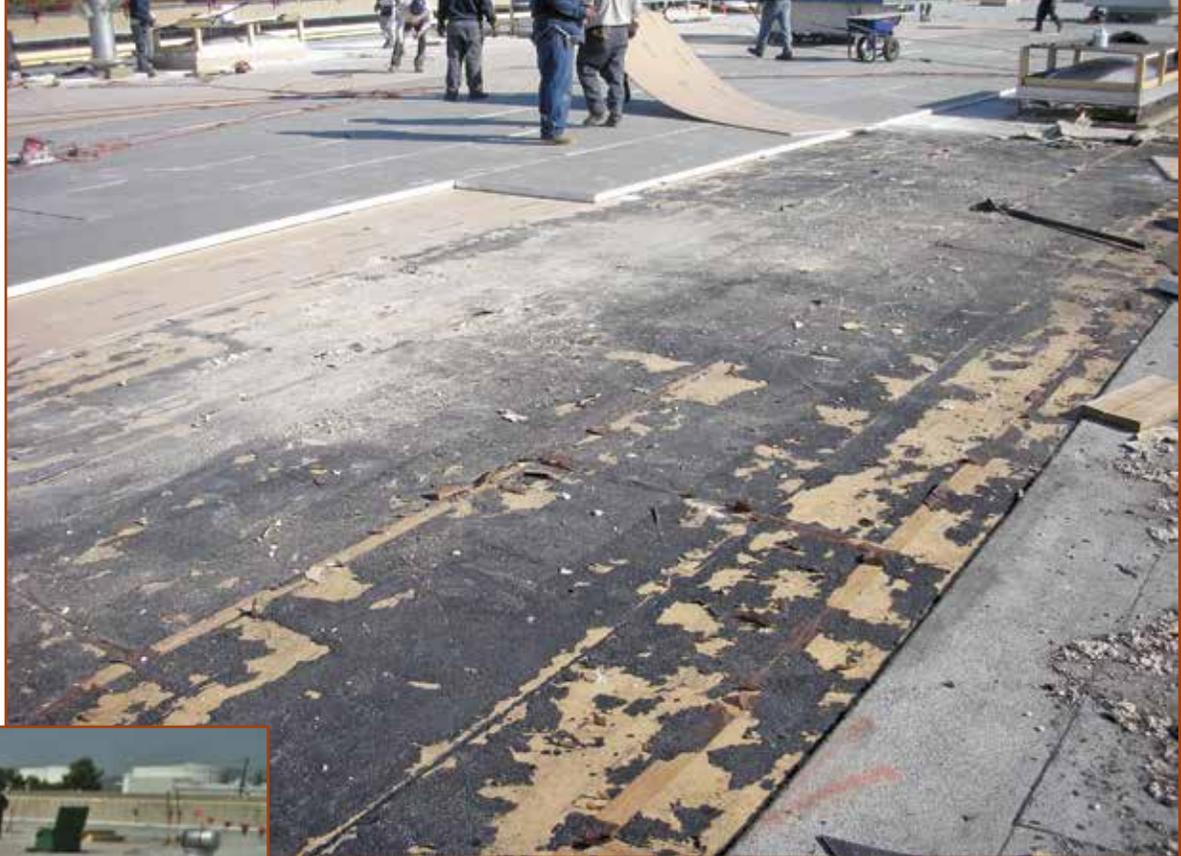
Installation of Loadmaster composite components after removal of existing roof coverings from Loadmaster roof deck.

After removing the roof coverings, any deteriorated or damaged steel deck sections should be replaced with new steel sections, and any damaged board or insulation materials should be replaced with new Loadmaster materials. Upon completion of repairs, optional insulation and a new dense

mineral board should be installed over the entire surface of the assembly and attached with the engineered screw attachment pattern as recommended by Loadmaster to recreate the SCA necessary to meet current IBC structural requirements.

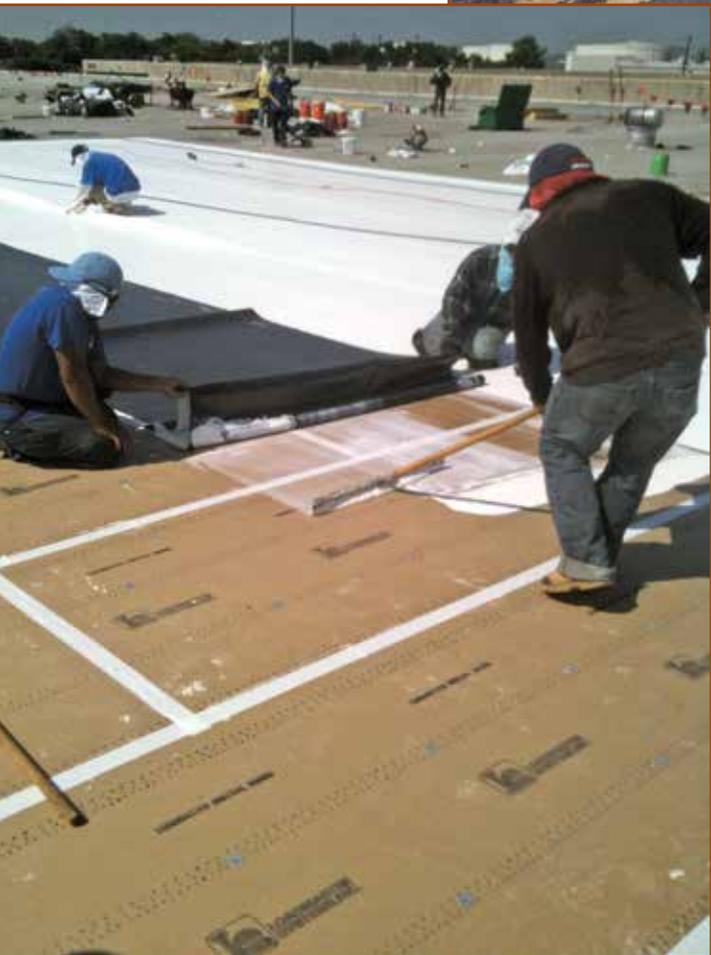
Installation of roof covering over retrofitted Loadmaster roof deck.

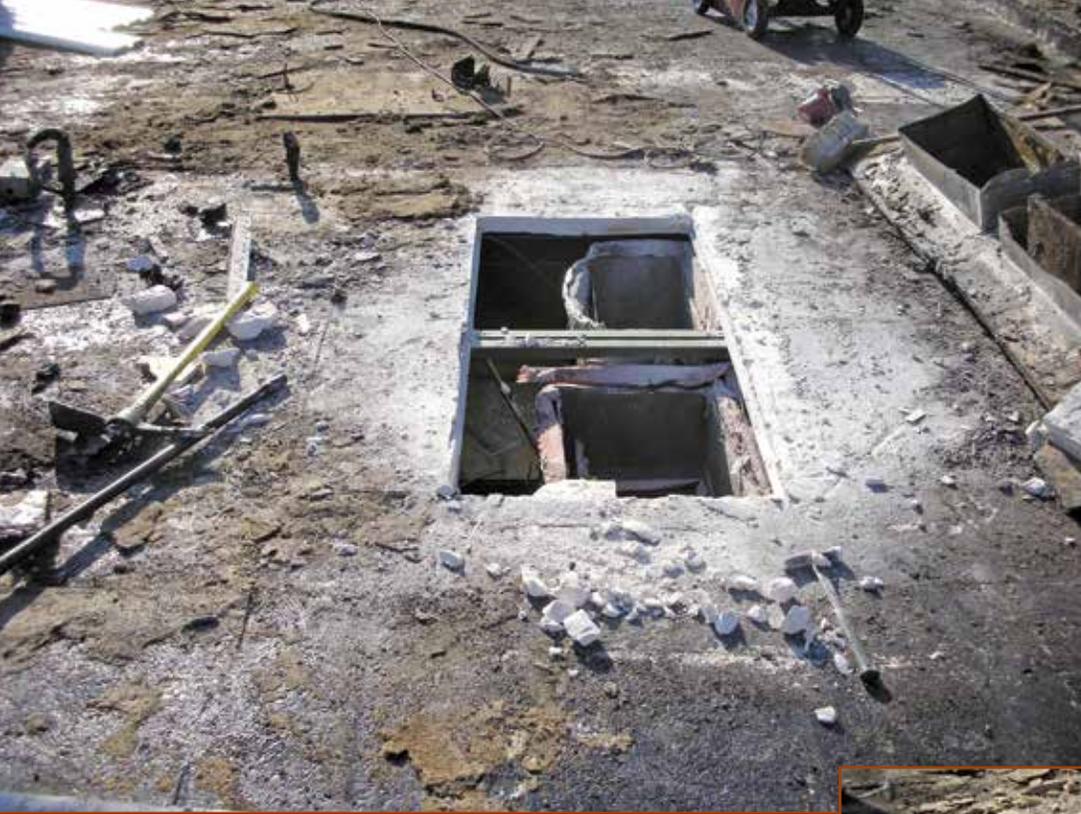
Gypsum roof deck-damaged area removed.

For a “no” answer, the repair or restoration of the SCA needs to deal only with gravity loads and wind-uplift loads. Damaged areas can be removed and replaced in two different ways—the wet way or the dry way. The wet repair involves removing the damaged areas from the bulb tees, cutting the wire mesh and leaving a selvage edge, installing a new form board to match the existing, tying in new reinforcing mesh, and repouring the patch with new gypsum concrete. Protection of the interior of the building will be required to prevent liquid gypsum from coming through the roof deck. When the gypsum has set adequately, the new roof covering may be installed.

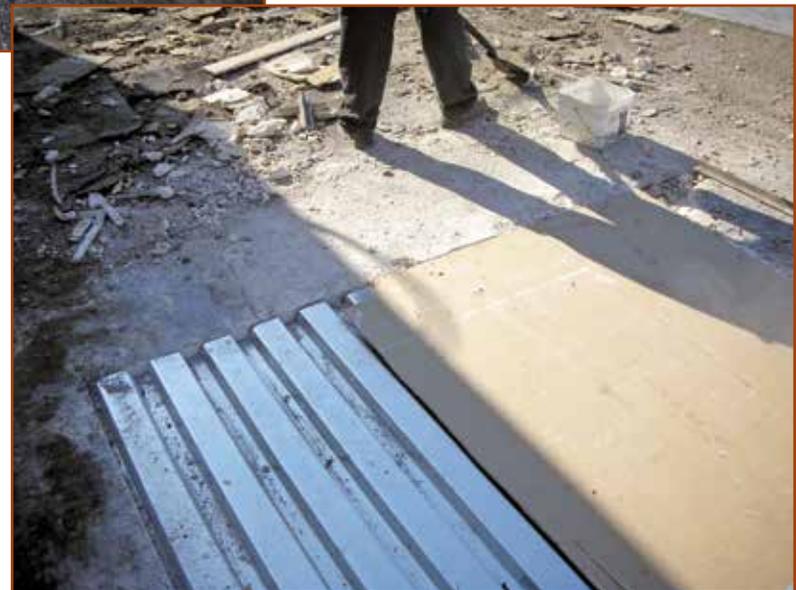
Damaged area of gypsum deck being repaired with “dry option” components.

The dry way involves removing the damaged areas from the bulb tees, cutting the wire mesh and leaving a selvage edge, and installing a steel deck section perpendicular and attached to the bulb tees with screws at intervals sufficient to brace the bulb tees against rotation under loads. Install optional insulation and mineral board to the steel section at an elevation equal to the height of the surrounding gypsum with an engineered screw attachment pattern to complete the SCA. Roofing can be installed immediately. The steel deck section can be flat or corrugated and painted a color to match the underside of the deck. If needed, an additional layer of insulation can be installed over the entire roof deck assembly along with the roof covering.
