# DESIGN ISSUES: *The Devil in the Details*

By Don Kilpatrick

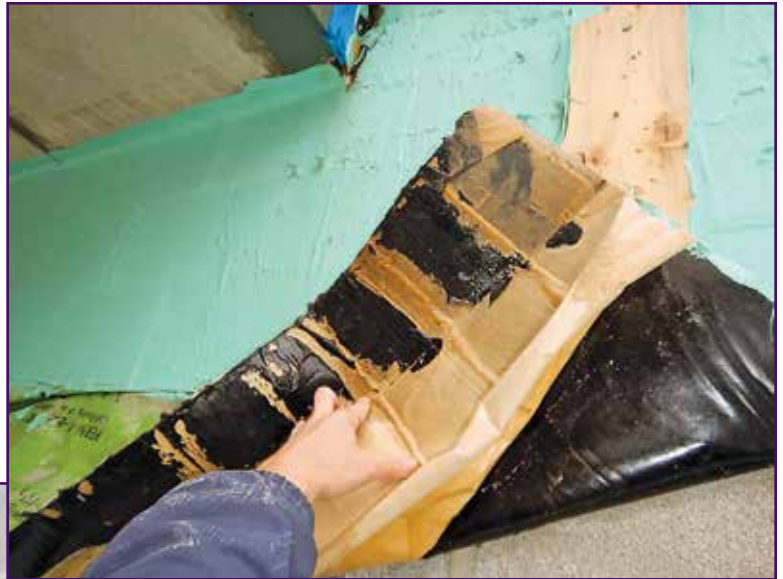
Figure 3 – Two months after seeing Figure 2, note the same TWF with intermittent loss of release paper and exposure to the elements, leaving self-adhesive or “sticky” side compromised to the extent that failure will occur.

fail. Most with experience in the field have firsthand practical knowledge with these types of shortcomings—while fulfilling the role of a third-party inspector, engaged to review a site-specific feature, or by chance observing construction site details or workmanship of marginal integrity. (It is hard to unsee some things; see Figure 1.) Each set of circumstances can cost building owners tens of millions of dollars. Some would argue that the default exposure is much more painful to watch, as it is accompanied by a sense of helplessness (Figures 2 and 3).

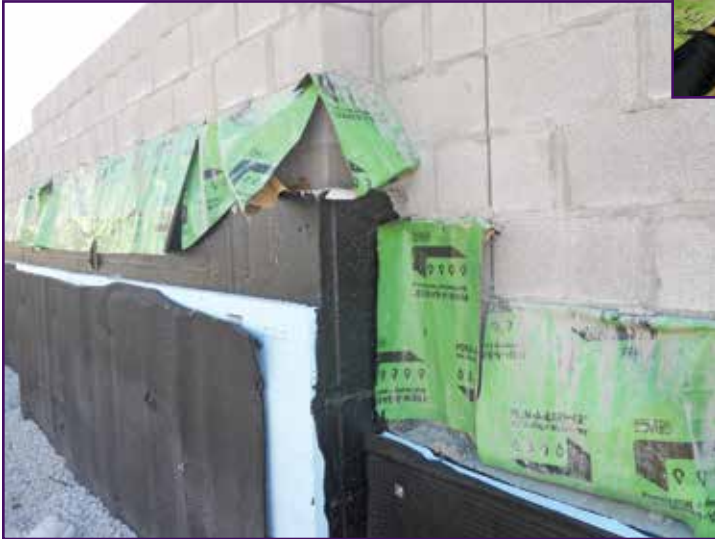
Figure 2 – Sight to be “unseen”—the birthplace of future performance issues with a through-wall flashing (TWF) condition.

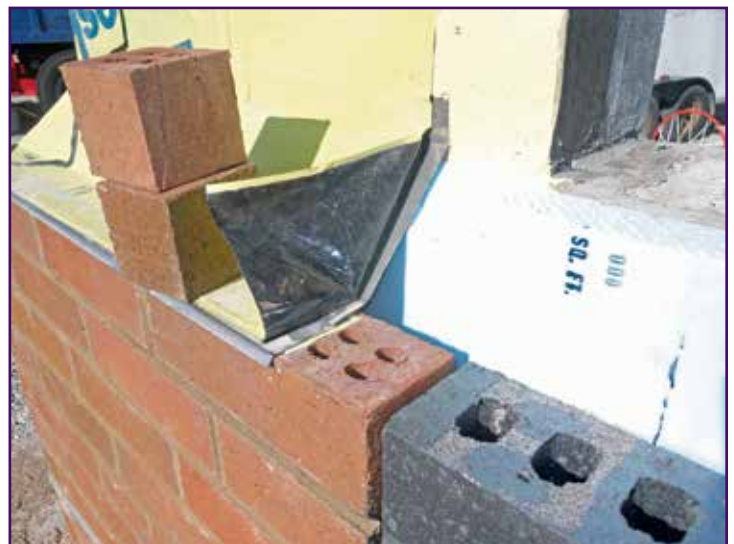
Figure 4 – Full-scale mock-up of a TWF condition on a new construction project. The design intent includes full support for the self-adhering membrane through the wall cavity.

of credibility. The process shall additionally acknowledge any special needs related to acceptance testing of materials, including full-scale mock-ups demonstrating proof of concept and standard of acceptance for the workmanship (Figure 4). On existing buildings, the consultant should work closely with the owner's in-house or outsourced environmental team, establishing proper protocols for hazardous materials, should they be encountered.

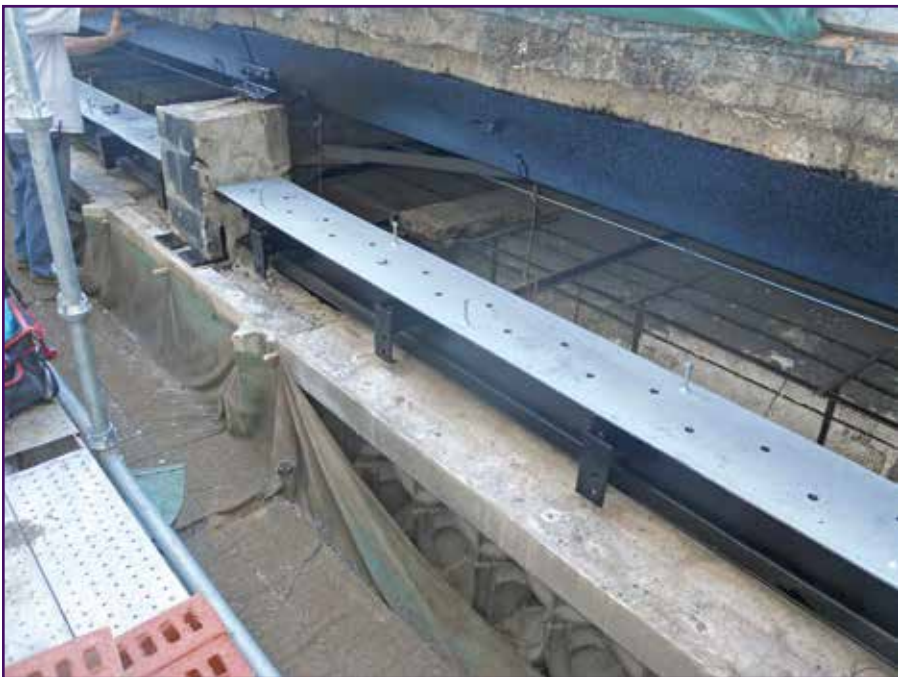
Figure 7 – Repairs underway at conditions represented by Figures 5 and 6.

In the example shown in Figure 5, after a few hours of investigation in the confines of a dirty attic space, the team emerged with a field sketch that brought clarity to the section found in the original building drawings (Figure 6). With an additional review of the structural drawings (more notably, the steel schedule notations), the field measurements were cross-checked against those shown on the drawings. The key parameters of the as-built condition were established to an extent that the team's efforts could move to full design with a comfort level that all variables had been acknowledged (Figure 7).

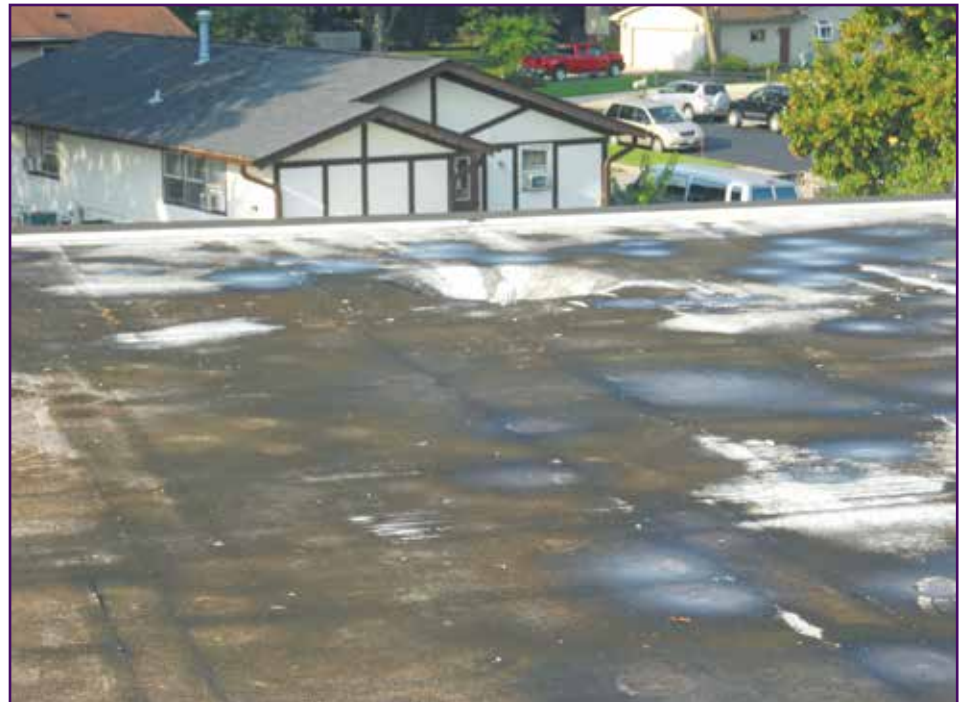
Figure 9 – The roof in this figure was designed by a manufacturer, with the owner under the impression that the service constituted “added value.” No efforts were made to improve drainage. Minimally, a tapered insulation section or sump at the drain heads would have been added value.

offer extended standard-of-care agreements as a supplement to the “added value” service of design (Figure 9).
