TAKE CAUTION WITH CONTINUOUS INSULATION:

Account for Differential Expansion and Contraction in the Design Phase

By J. Lawrence Elkin, PE, CCT

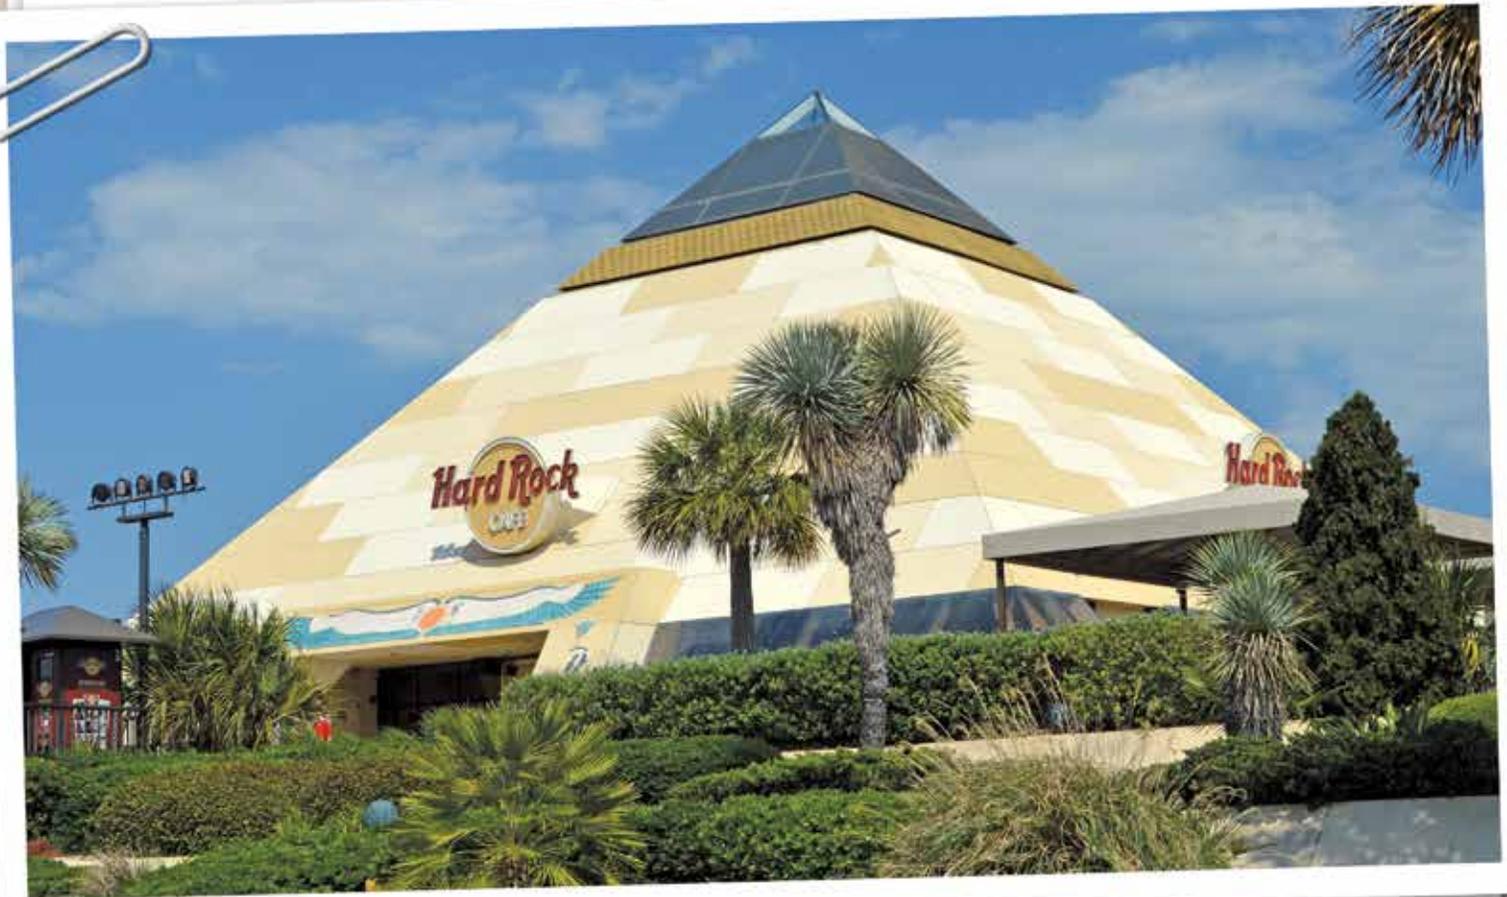
Figure 1 – Hard Rock Café in Myrtle Beach, South Carolina.

During my investigation of the Hard Rock Café facility in Myrtle Beach, South Carolina, I arrived before sunrise one morning to measure movements in the cladding as the sun warmed the surface. The custodian met me outside and asked what I was doing. “I’m just making some measurements to see how the building was built,” I replied. He looked at me very seriously, then looked at the building and then back at me again. Very slowly he stated, “It’s built like a pyramid.” True enough! (See *Figure 1*.)

The restaurant, built in 1995, was indeed constructed to appear like the stone pyramids in Egypt. However, this modern incarnation of the classic structure included a wide-flanged steel frame that supported a wide-flanged steel frame that supported steel purlins, steel decking, and a cladding

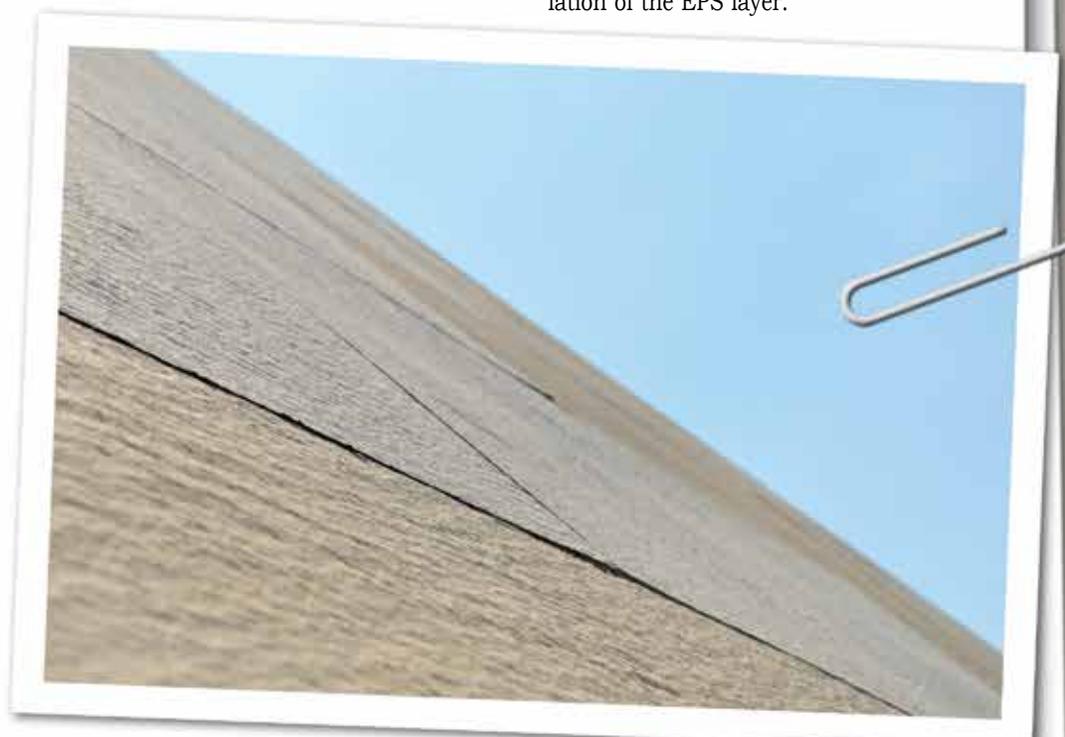
The exterior wall cladding assembly was completed in early April 1995. However, reports that the panels were visibly deformed arose by October of 1995. The panels exhibited upward curling of the panel edges and “pillowing” of the middle portions of the panels. In other words, the panels remained tight to the structure at the cleats but deflected away from the structure between the cleats (see Figure 3). By spring of 1996, the pan-

els had flattened, but the sealant joints were at the lower limit of their allowable widths. As summer progressed, the panels began to deflect and the sealant joints began to rupture as they became excessively small (Elkin 2004).

Figure 3 – View of deformations.

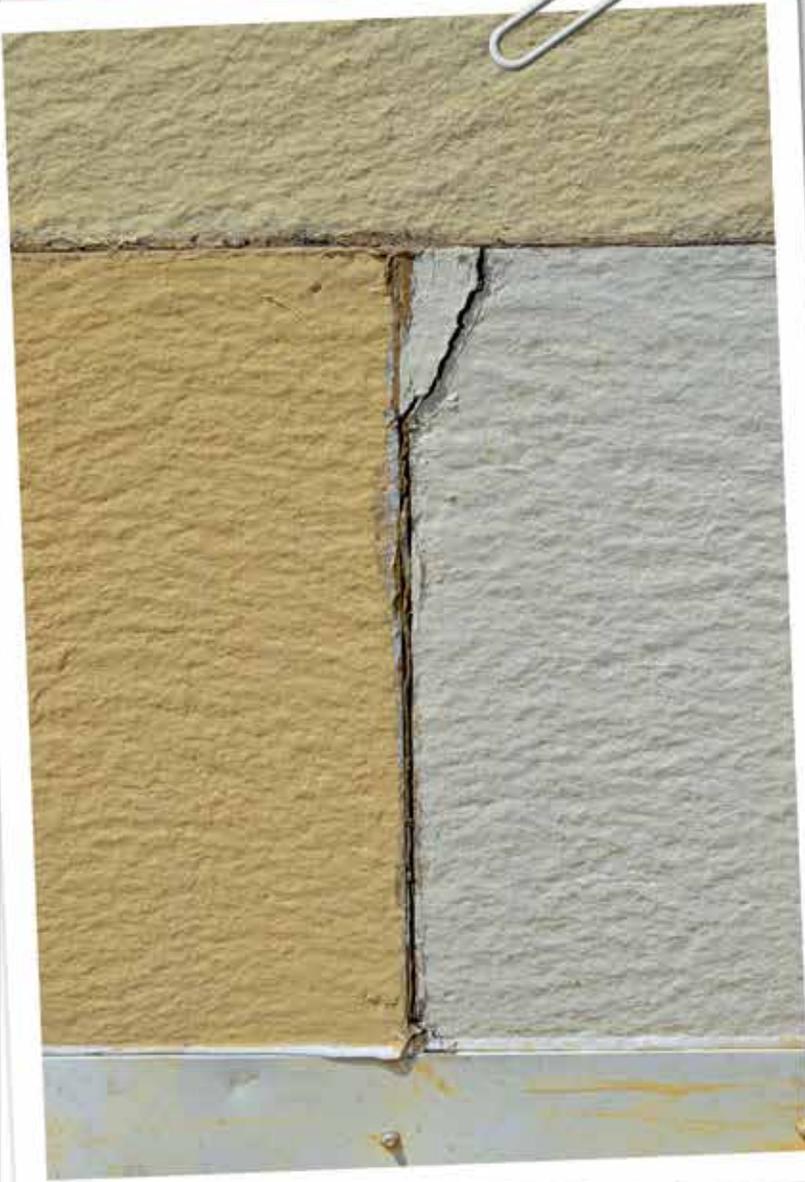
The second hypothesis was that the cladding assembly was experiencing unanticipated differential movement across its various layers (Figure 4). The genesis of this theory resided in the manufacturer’s requirement that plywood substrate be fastened directly to the structure. The as-designed/as-built assembly included 3½ in. of EPS between the plywood and the structural steel deck. Had the plywood been screwed directly to the steel, the fasteners would have been placed primarily in shear when the steel and wood expanded differentially. As such, the fasteners would have limited the relative movement of the wood and steel. However, the long screws that extended through the EPS would have been subjected to unrestrained bending when the wood and steel expanded differentially. Figures 5A and 5B depict the differences in the fastener loadings created by the installation of the EPS layer.

Figure 4 – Differential movement of the wall assembly resulted in excessive compression of the sealant joints and interferences between adjacent panels. Ultimately, this panel fractured as a result.
