ELECTRIC FIELD VECTOR MAPPING (EFVM)

By Chris Eichhorn, RRO

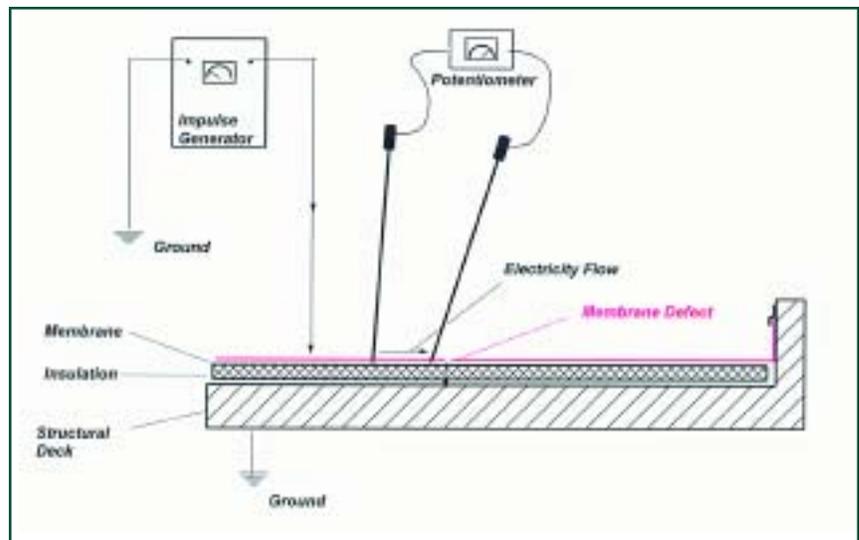
Figure 1: EFVM operation principles.

The EFVM technique uses water as an electrically conductive medium; therefore, it is essential that the surface to be tested is wet. If it is not raining at the time of the survey, then water needs to be sprayed over the area. Once the area is suitable for the test, the survey technician installs an un-insulated wire loop around the perimeter of the area and connects the electrical pulse generator to the wire. The electrical pulse generator delivers a 40-volt potential for one second every three seconds. The pulsating potential on the wet roof surface forms an "electrical plate." The grounded structural deck is the other "electrical plate," while the membrane separating the two plates acts as the insulator. If moisture enters a breach in the membrane, an electrical contact is established between the two plates (i.e., an electrical ground).

Using a potentiometer connected to two probes, the survey technician steps into the

electric field and places the probes on the surface. If there is a breach in the membrane, the dial on the potentiometer will move either to the left or to the right. The survey technician can

then follow the direction of the electric field to the membrane breach. Because of the high electrical resistance through the roof, the magnitude of the electrical current is relatively small.

However, the magnitude of the current is not important, but the direction of the current flow is what leads the survey technician to the breach.

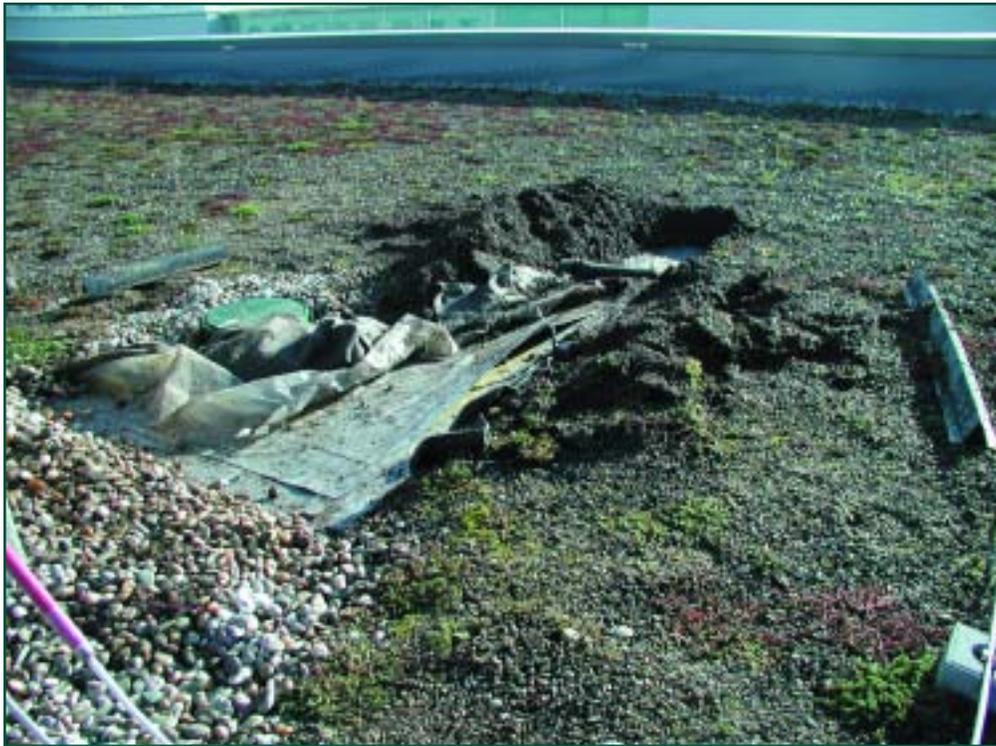
Figure 2: Leak investigation on a green roof in Frankfurt, Germany.

A recent project in Frankfurt, Germany, further illustrates the value of EFVM as an asset management technique. This project involved an 110,000 square foot roof that was installed in 2000. The technicians found 17 defects in the membrane. Some of these flaws were located in defective seams (workmanship) while others were found to be tiny punctures. There was no visible water damage in the interior of the building. The building owners did not know that there were any problems and probably would not have found the flaws until the insulation had become saturated.

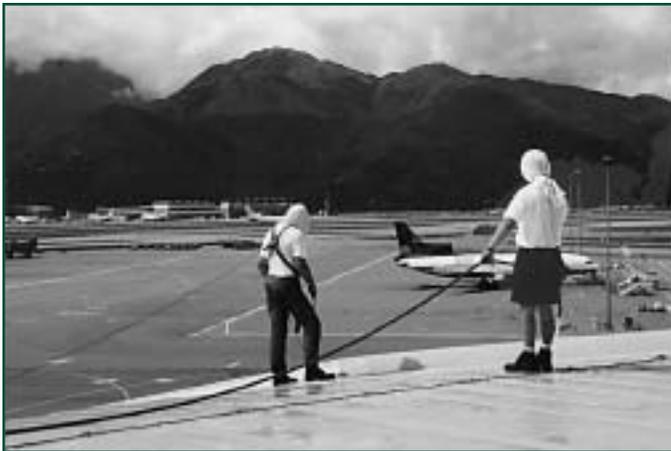
Figure 3: Leak detection at Chek Lap Kok airport, Hong Kong. Applying continuous flow of water on the sloped PVC membrane to facilitate the test.

EVFM was used as a quality control measure at the Chek Lap Kok Airport in Hong Kong. A total of 165,000 square feet was electronically surveyed, and over 100 breaches were located in the membrane. The contractor was still on site at the time of the testing and repaired the breaches on a daily basis. The repaired areas were tested upon completion by the survey technicians to ensure the membrane was 100% watertight. A new addition, presently at the developmental stage, will include the EFVM test as part of the specifications.

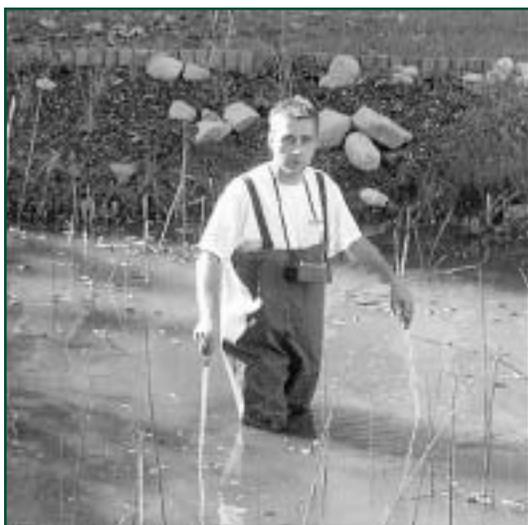
Figure 4: Locating leaks in a geo-membrane liner with the EFVM technique.

Geo-membrane liners and/or containment liners are also beneficiaries of the EFVM test. These membranes can be tested for any defects prior to commissioning their use and, depending on the depth of the containment basins, also during their use.

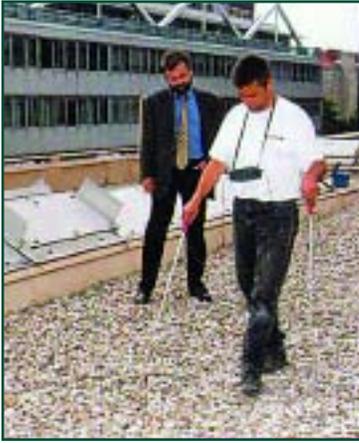
Figure 5: Leak detection procedure on an inverted BUR roof system. Locating breach through the ballast and insulation.

The EFVM method has proven highly advantageous in situations where the waterproofing is concealed or buried. These include IRMA (Inverted Roof Membrane Assembly) configurations, plaza installations, ballasted roofs, and "green roofs." Green roofs are veneer landscapes installed on top of conventional roofs. They may be anywhere from 2.5 inches to 3 feet deep.
